ANALYSIS OF REHABILITATION SOLUTIONS FOR MASONRY BUILDINGS

A. PODAVKA¹ S. DAN¹ A. POP¹ M. COCIUBAN¹

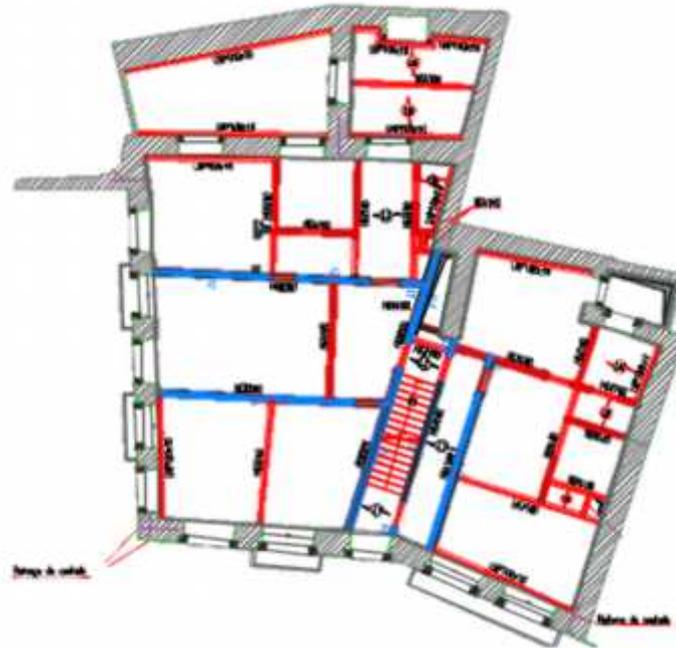
Fig. 1. *Plan of the analysed building*

After a diagnostic study was performed, evident signs of large deformations, both at the level of the floors and at the level of the frontal walls, were identified. These deformations were caused by two main factors: the first one is related to the phenomenon of decompression and decompression of the constituent sands of the foundation soil and the second one by the lack of vertical continuity of the frontal alignments at the ground level.

The large deformations of the existing floors and the lack of continuity of the vertical alignments at the ground level and the deformations of some frontal walls, led to the decision to completely demolish the interior, with only existing masonry walls remaining. Thus the solution involves the reconstruction of the frontal walls needed to support the floors in the same alignments as those already existing and the reconstruction of the existing staircase as it is.

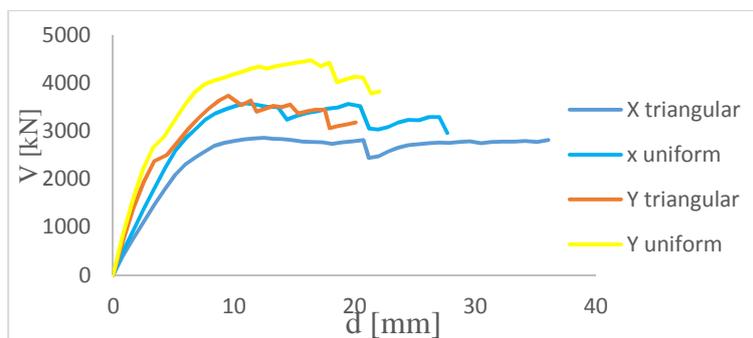
Fig. 3. Pushover curves in the two directions for both uniform and triangular load patterns

Based on the results obtained we can notice that the stiffness and strength of the building is a little bit higher in y direction. On the other hand, the ductility of the system is higher on the X direction. In both directions piers are very slender (due to the opening's configuration) and with a very moderate coupling provided by spandrels.

Comparing the results obtained with the two lateral load patterns, it can be seen how the triangular load pattern is more demanding than the uniform load pattern, since the curves run below the later ones.

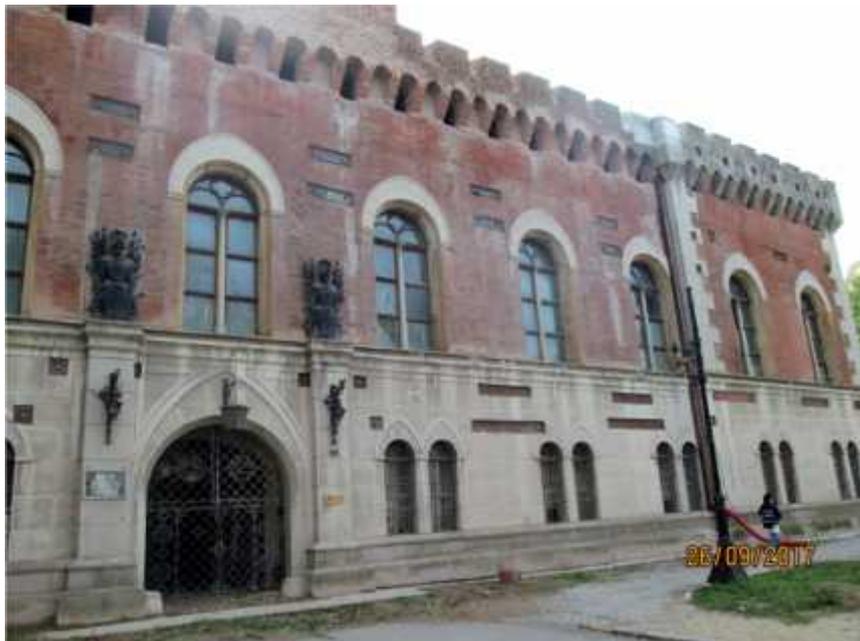
Fig. 4. *The Banatul Museum building*

The Banatul Museum (Fig. 4) is one the most important historical building in Timisoara, Romania. The first site of the Huniade-Castle is mentioned in the XIV century. Bad soil conditions and soil water level had affected the castle building which was re-erected or rehabilitated many times: in the period 1720-1750 timber pilot foundations were used; in 1848 it was destroyed by fire and rebuilt in 1850-1856 in the present-day form.

The presence of eight reinforced concrete piles around each existing pillar foundation of the Hall 2 contributes to a stabilisation of the three columns. After 40 years, the settlement of Hall 2 columns was insignificant as compared to the settlement values of 24-39 mm under walls. The data concerning settlement were obtained by topographic surveying on markers displaced on the building in 1959. In 1980 there was performed a building maintenance, with filling up the cracks, but after a few years the cracks are still present in building structure.

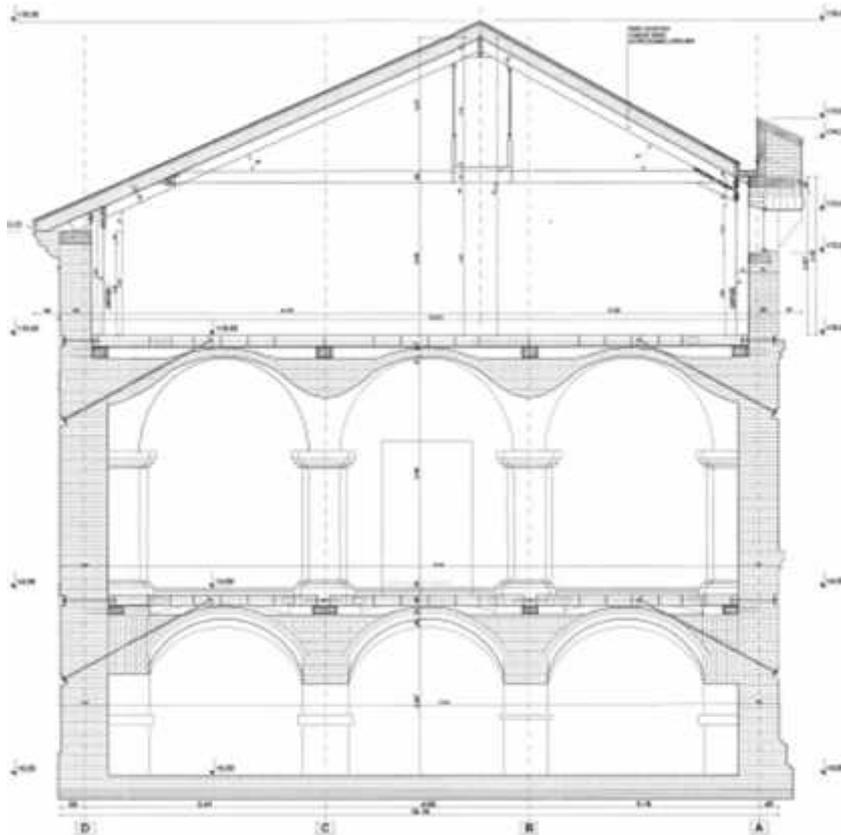
Fig. 6. *Cross section of Hall 1*

The main damages of the actual structure of the building are located inside the Halls 1 & 2 and are characterised by cracks in the masonry walls: maximum width of 5 cm at upper part (Hall 1) as well as in the brick arches, especially in the vault head (5-8 mm). Such cracks were caused by both, earthquake actions and soil settlement due to bad soil, non-uniform foundations and soil water level.

- under the floor above de ground floor and first floor, some transversal pre-tensioned tie-rods consisting of UNP 260 profiles were introduced, supported by reinforced concrete perimeter plaster and anchored in the exterior walls (Fig. 6);
- strengthening of arches and vaults (Hall 1 first and second floor, Hall 2 first floor) by introducing oblique pre-tensioned tie-rods anchored in the exterior walls and to the transversal tie-rods., which prevent the development of existing cracks and the development of new ones (Fig. 6);
- at the crown of the perimeter walls a reinforced concrete lintel cast was executed, that serves not only as a belt but also as a support for the new roof cover consisting of a steel frame structure;
- at hall 2 second floor a reinforced concrete slab was casted.
