THE STRUCTURAL REHABILITATION OF THE BASEMENT OF A BUILDING WITH BRICK MASONRY STRUCTURE

Abstract: *The paper presents the structural rehabilitation solution that was applied to the basement of a masonry building, design at the beginning of 20th century. In the first phase of structural evaluation, was determined the causes of masonry decay based on visual and on site investigations. Secondly, was evaluated the building safety and proposed the strengthening solutions. The strengthening of the masonry columns was made with reinforced concrete jacketing and in the area where the vault collapsed were used a new structural system made of steel.*

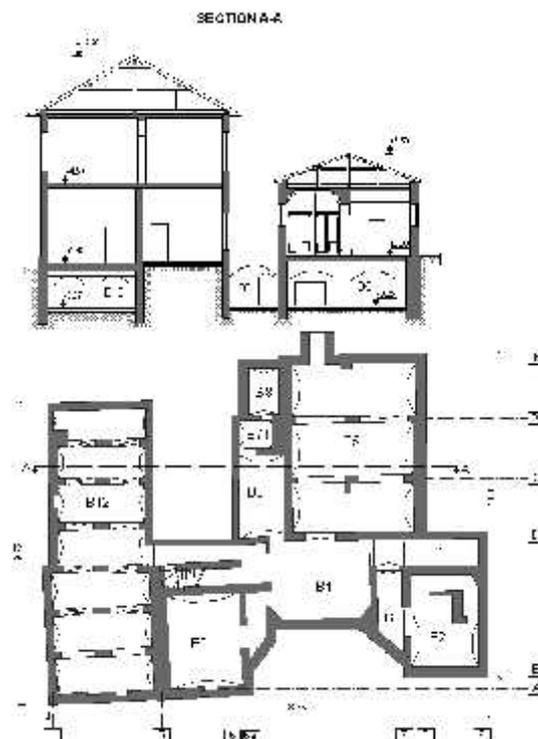
Fig. 1. Basement floor plan and A-A Cross section

At the basement level, occurred a total collapse of the masonry vaults in the room 5, 5a, of arches from axis D2 and column from axis D2 (Fig.1).

From on-site investigations it was found that the columns' foundations were approximately 20-30 cm deep in the ground. Degradations were also found in the columns placed in the D1 axis (Fig.1).

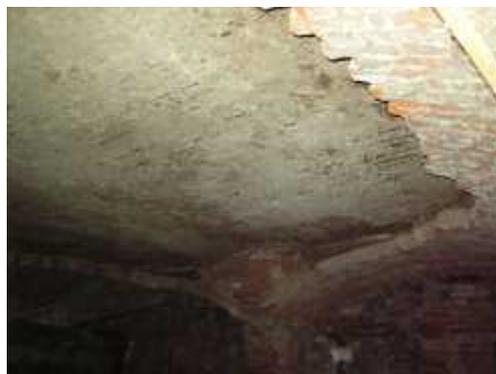
Observations in situ showed that the structural damage stops at the level of the basement, mainly caused by the action of the rainwater and from the damaged pipes.

The damage of the bricks especially in the columns from axis D2 (Fig. 1) and its associated foundation, led to a poor balance and consequently to the collapse. The column collapse, led to a local collapse of corresponding arch and adjacent vaults (Fig. 3), without breaking down the equalizer layer under the ground floor.

Fig. 3. *Collapse of the vault*

The collapsed area was retrofitted by using new structure made of steel to substitute the collapsed structure. The columns of the new steel structure were provided with their own foundations (Fig. 7).

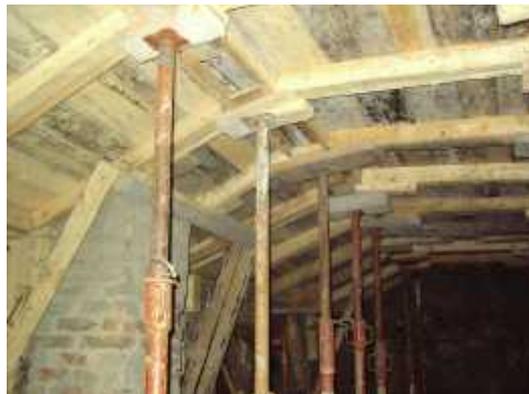
Fig. 4. *Scaffolding erected to support the reinforced equaliser layer form ground floor level*

In order to assure the safety work conditions in the first phase of interventions, the water from the basement has been evacuated by lowering its level and maintaining the level below the basement floor, and in the second phase a passageway were build (Fig. 4) to protect the workers during the execution phase.

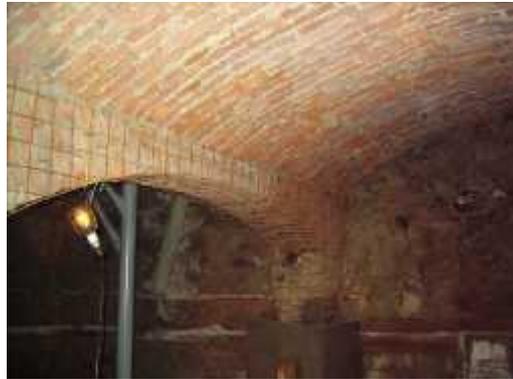
Fig. 5. Arch reinforcement

After the reinforcement of the columns and foundations was finished, the arch was reinforced and shotcrete layer was applied (Figs. 5-6)

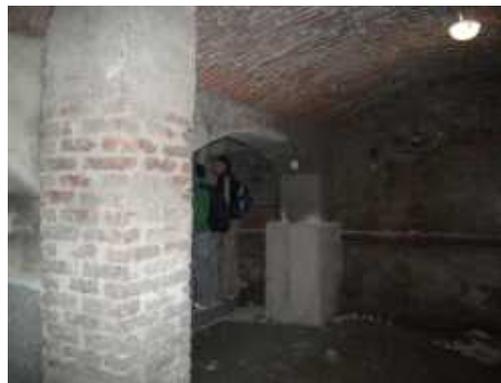
Fig. 6. Strengthening of arches and columns

Since the column from D1 axis had major deformations, were retrofited by reinforced concrete jacketing starting from the foundation level. Subsequently, the foundations were strengthened from lateral side, respecting four stages of realization.

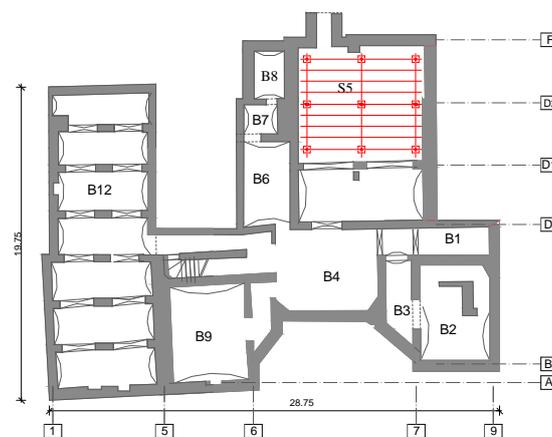
Fig. 7. The rehabilitation solution provided in areas with problems

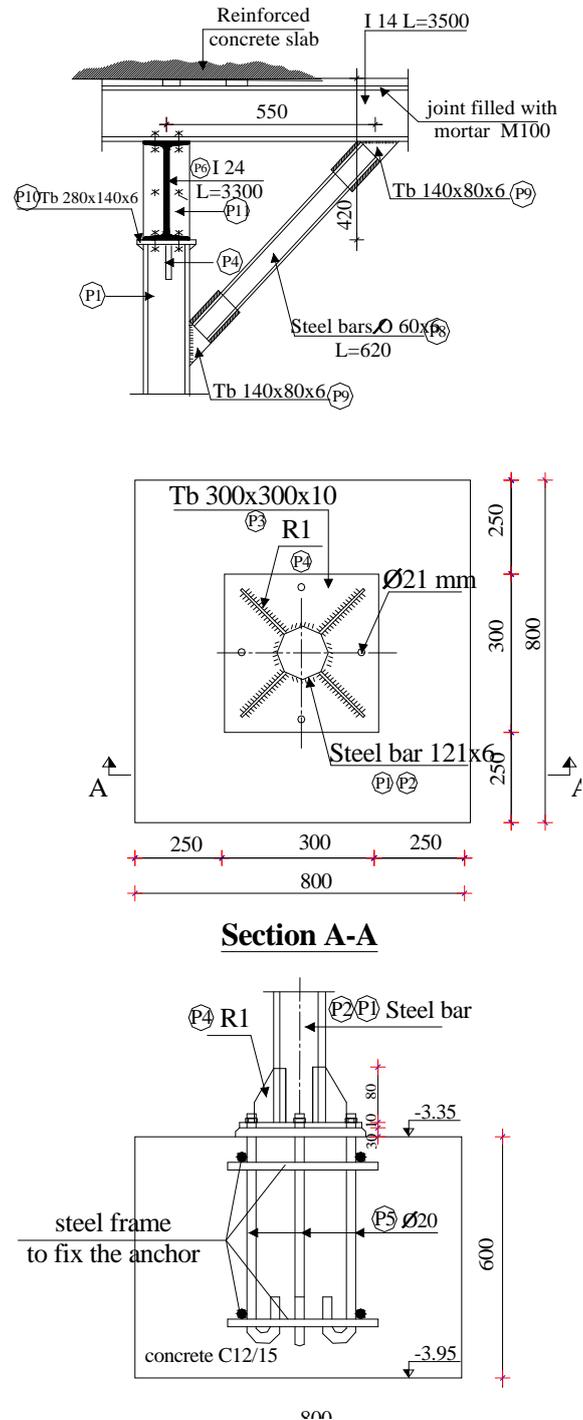
Fig. 8. Elements of new structure

The details of realization of the new structure, are presented in Figure 8 [12], and aspects during the execution in Figure 9.

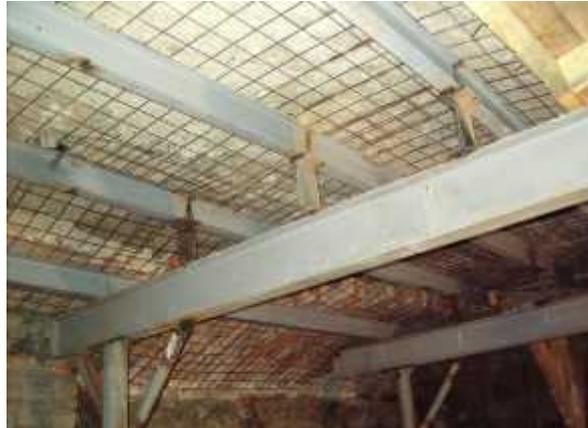
Fig. 9. *Vault reinforcement details*

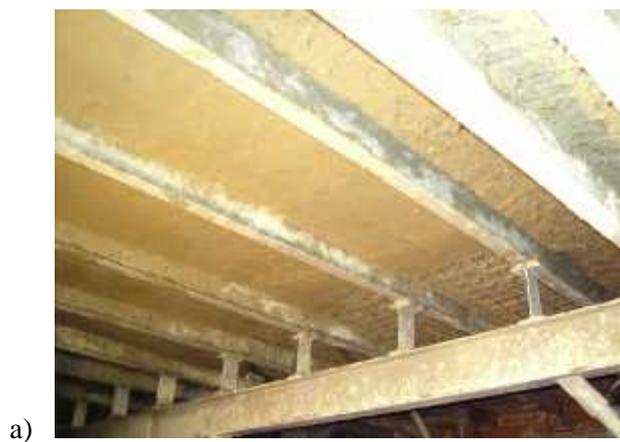
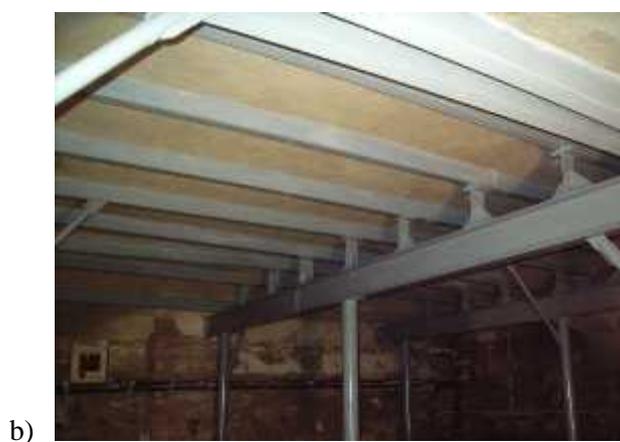
Fig. 10. *Aspects during the execution works: vaults overconcreting (a), after the rehabilitation (b)*

Details during and after the rehabilitation works were completed, are shown in Figure 10.
