CONSOLIDATING NEWLY BUILT MOTORWAYS – A COSTLY AFFAIR CASE STUDY

This article describes in detail the methodology applied to consolidate the areas that started to degrade right after the commissioning of the Orăştie-Sibiu motorway section, Lot 3. Since 2014 onwards this section has been extensively covered by the media as the most recklessly built portion of the motorway.

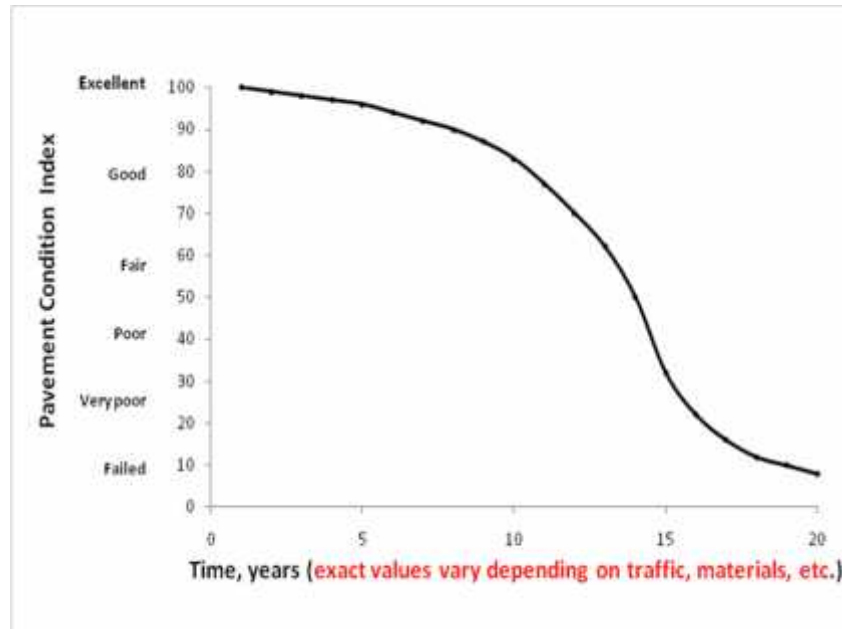
Fig. 1. *Degradation of the road structure*

In the case of the “Or tie-Sibiu Motorway, Lot 3”, at the time when the section was commissioned, degradation started to appear, mainly in the form of longitudinal and transversal cracks in the carriageway and of embankment settlement and collapse. Looking at Figure 1, we realize that the occurrence of these cracks indicates an advanced state of road decay, standing at a value of about 50.

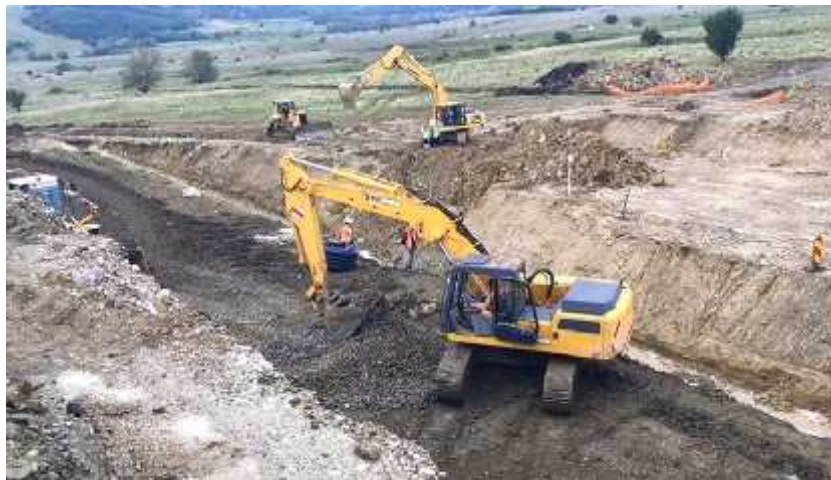
Fig. 2. *Excavation of the cross drains [2]*

The consolidation works were completed with the restoration of the protection with vegetable earth and water drainage works capture (drains ditches and culverts). The technical solution to be implemented consists of the execution of six draining trenches, dug at a depth of seven meters, transversally on the motorway territory, and spaced apart at a smaller distance from one another at the higher part of the embankment, with the spacing increasing as the height of the embankment decreases. The trenches will be 65 m long, for four of the drains, and 285 m long for two of them. Downstream of the 65 m long trenches, manholes will be installed, interconnected to one another. The 285 m long trenches have a twofold role: to discharge the drained water into the emissary running in the downstream and to dewater the marshy area located approx. 200 m far from the motorway. The

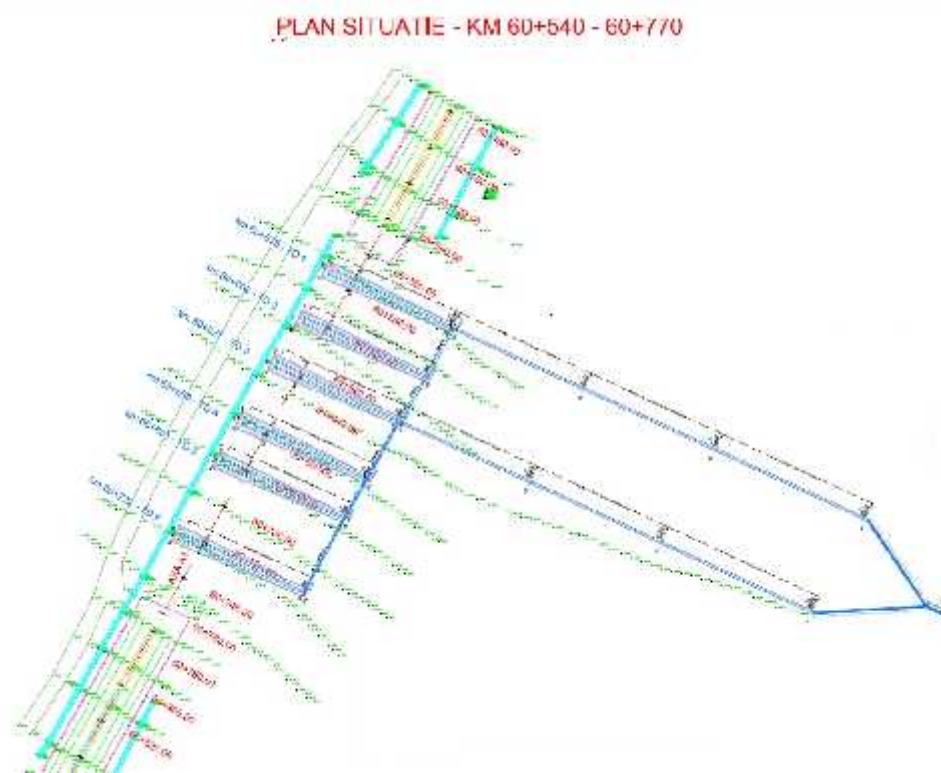
Fig. 3. Positioning drains.

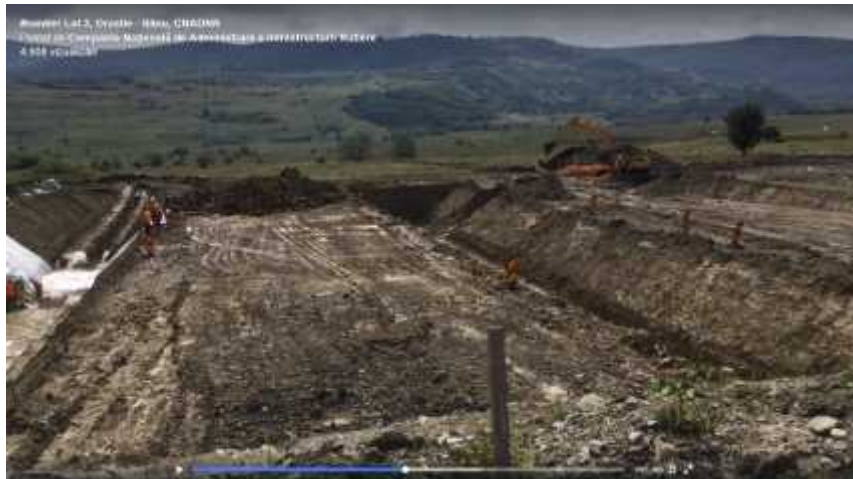
Fig. 4. Digging drain

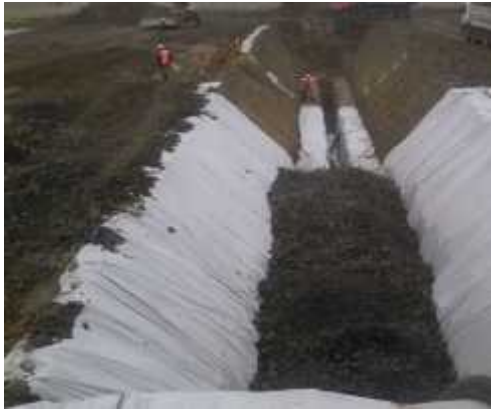
Fig. 5. *Geotextil putting in work [3]*

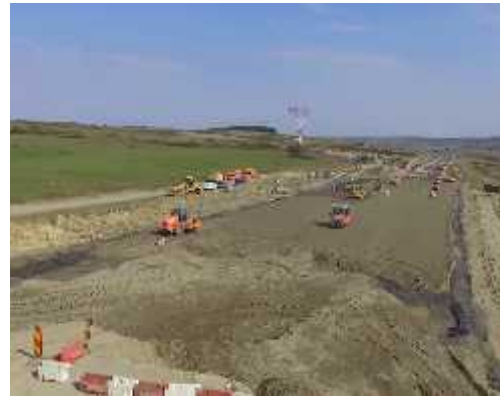
Fig. 6. *Building of the embankment [3]*

- the bottom of the embankment will consist of a cushion made of crushed stone and reinforced with geogrids; the cushion width will be larger than that of the road footprint, thereby reducing strains;
- the reinforced stone cushion will prevent lateral deflection by the wedging effect
- the cushion will be 1.50 m thick and it will be reinforced with 4 layers of geogrid. The embankment body is designed to be made of 0 – 63 graded gravel.

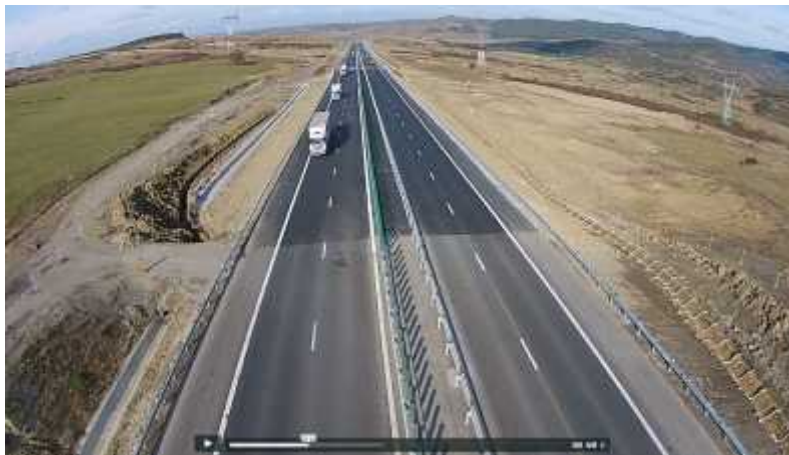
was that it focused on diverting and blocking out the ground waters, while ignoring the capturing of the underground waters. Figure 8 shows the current state of works to strengthen embankment, including the timing of commissioning of the closed portion of highway traffic.

Fig. 8. Current state of works
