LAND SLIDE STABILIZATION FOR A WORKING PLATFORM WHICH OCCURRED DURING EXCAVATION IN CLUJ-NAPOCA

I. ABRUDAN¹ C. PLESCAN²

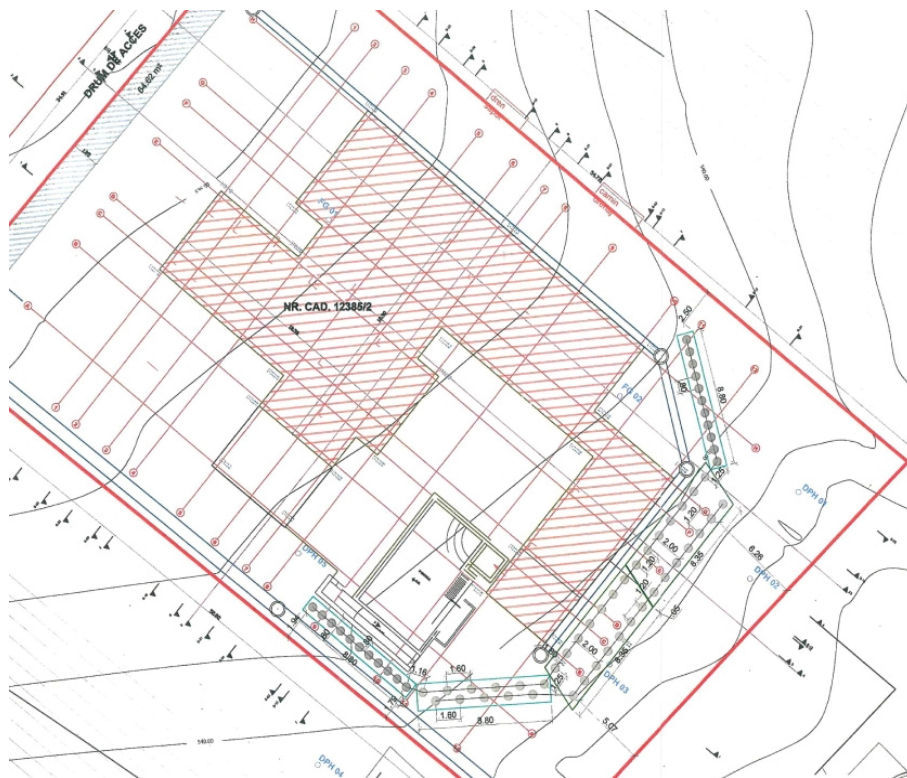
Fig. 1. *Building and consolidation plan*

In short time after the excavation began the earth started to move from the right upstream of the excavation. The earth movement was caused by the big excavation height, but the area of the landslide was much bigger than the slide caused by excavating using big slopes. Upstream from the new building location was a small swamp that was probably the remains of a former landslide in the neighbor area. In the nearby region of the excavation the wooden floor from the ground level of a coop was showing signs of recent movements, the fence between neighboring properties were showing signs of movements and some cracks started to appear in the soil. The landslide area was very close to some buildings in the area, but none of these were showing signs of movement or cracks.

The length of the landslide affected area is about 20m, from which 10m on the upstream terrain. The width of the affected area is about 35 m from which 8m are on the right side neighbouring terrain. After the landslide was produced, the constructor filled the excavation with earth. After this fill the landslide did not evolve significantly.
