# REHABILITATION OF TWO HISTORICAL BRIDGES IN BAILE HERCULANE ROMANIA

**Abstract:** *The paper presents the history, the present technical condition and some rehabilitation proposals for two bridges erected in the 19th century in the famous Spa from Baile Herculane near to the Danube. The first structure is a steel foot bridge constructed in 1837 made from wrought iron with the span of 32,2 m. The maintenance of the bridge was neglected; the present technical condition is very poor. The second structure is a masonry arch bridge with 2 spans of 16,5 m and 12,5 m. Some proposals for the rehabilitation of both structures are presented.*

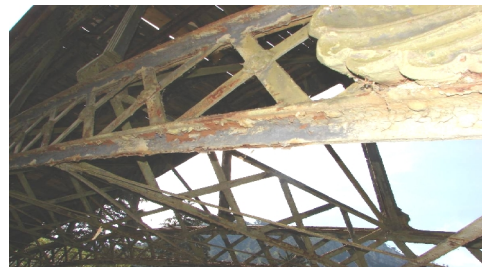
The structure had a good behavior in time, although due to poor maintenance to the age several problems appear: numerous corroded elements.

Fig. 6. *The corroded arches*

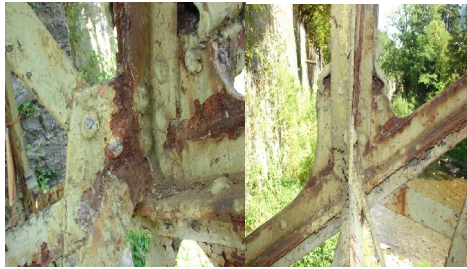
At the main elements you can find a lot of areas with destroyed anticorrosive protection.

Fig. 7. Corroded joint and vertical member

The distance between the rivet at joints was found inadequate ( $d_{\max} = 6d = 6 \times 19 \text{ mm} = 120 \text{ mm}$ ), causing corrosion between elements.

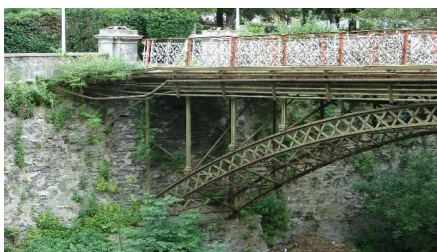
The connection between the infrastructure and the embankment is partially destroyed. Vegetation growth can be observed.

Fig. 8. Vegetation growth

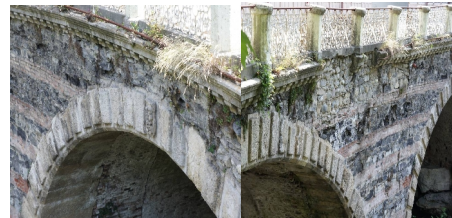
- masonry elements are severely damaged;
- water infiltration;
- vegetation;
- damaged soft stone;
- degradations, absence of stone masonry,
- deformations, instabilities, inadequate repairments and vegetation
- ornaments are missing

Fig. 9. Vegetation, damaged masonry elements

- elimination of road layers;
- a repair, rebuilding the vaults in their original form and consistency to ensure lateral stability, uniformity and aesthetics of the bridge;
- cleaning, filling, repair of the bricks at the spandrel, including their protection;
- strengthening the vaults at the extrados or intrados in collaboration with the existing construction.

- Construction of a new path by introducing reinforced concrete slabs;
- a masonry repair, cleaning degraded stone masonry all over the bridge;
- a repair of the ornaments.

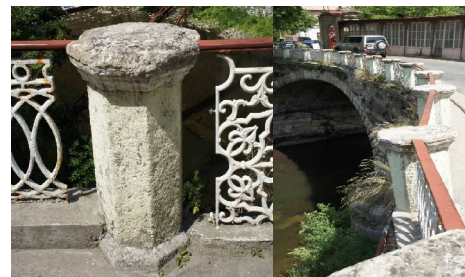
Fig.10. Ornaments are missing

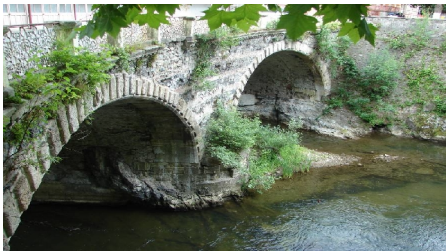
The bridge infrastructure is built up of stone masonry and it shows the following problems: erosion, cracks, scouring, and separation. Scoring and missing stone masonry elements can be observed

The riverbed is clogged with different waste and wooden scraps in the zone of the front-breakwaters. The support walls sustaining the riverbed are partially destroyed.

Fig. 11. *The bridge infrastructure*
