FAULTS FOUND IN SEWER PIPES, CAUSES AND REMEDIES

T. V. CHIRA¹

Key words: *sewer pipes, faults, CCTV inspection, pipe rehabilitation.*

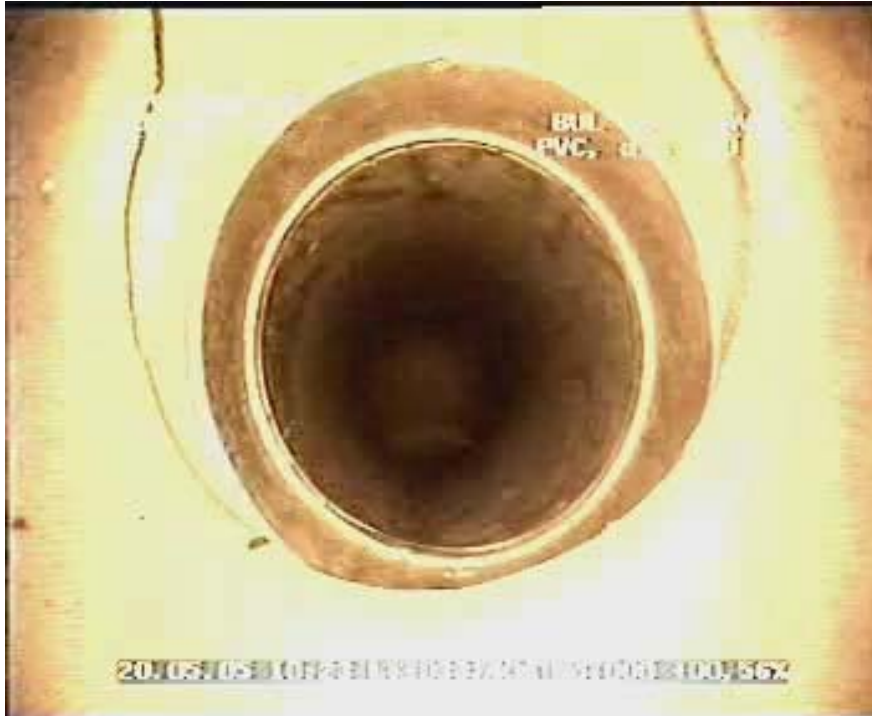
This may lead to cross sectional shearing of the pipe when big loads are applied on the less compacted portion of the soil. Shearing is possible also in case of landslides. In other circumstances it's possible to have less compacted soil on the sides of the sewer main and when the laterals are loaded heavily they could break the mains wall at the joint. Figure 1 presents such a case. Cracks or breaches could also be caused accidentally during interventions on other networks adjacent to sewer by digging machinery and equipment, especially when the sewer section is older and less well documented. By implementing modern tools for network mapping and documenting like GIS (geographic information system) we should be able to avoid in the future these incidents. Sometimes the cracks are caused by increasing loads combined with aging of sewer infrastructure. In most cases the sewer lines are underneath roads circulated by heavier and numerous vehicles. In these cases longitudinal cracks appear on the upper side of the pipe and if the reinforcing is exposed the pipe will collapse when it corrodes.

Fig. 1. Cracks in the wall of a PVC sewer main at a lateral joint due to uneven soil compaction and the lateral acting as a lever

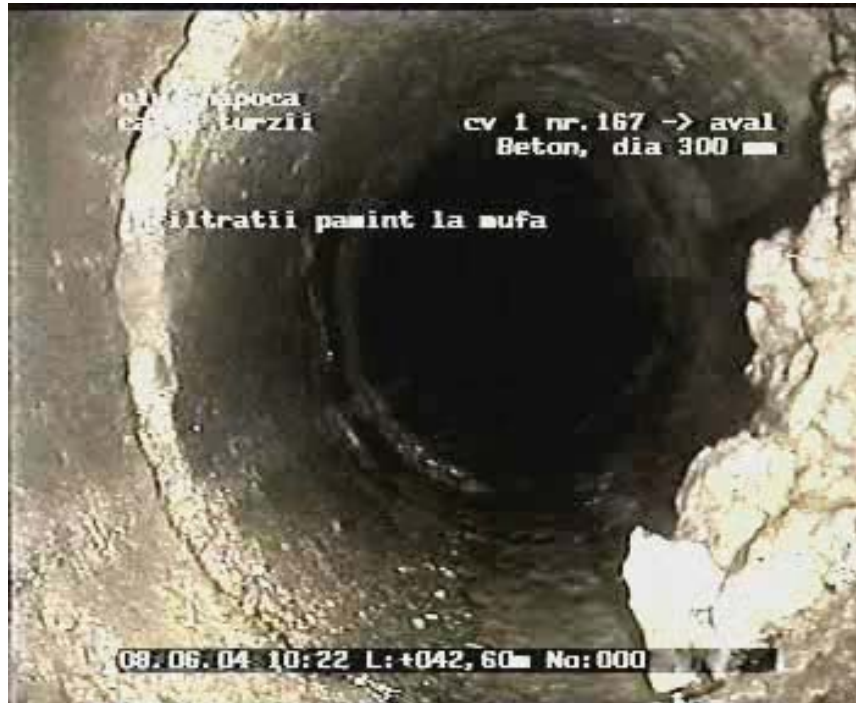
There are several types of faulty joints. In some cases, when the sealing is done with rubber gaskets the sealing is lost because when the pipes are connected they are not properly aligned and the gasket is expelled from its groove. This mainly occurs in PVC and GRP sewer sections. Another reason for gasket expulsion is the lack of a proper lubricant on the entire length of the gasket. In other cases when the sealing is done with mortars or other compounds in time they fall from the joint and the sealing is lost. Obviously, these faulty joints are big sources of infiltration of ground water or exfiltration of waste water. In Figure 2 a faulty joint in a concrete pipe allows soil to get inside the pipe and in Figure 3 a.

Fig. 2. Faulty joint in a concrete sewer section allowing soil to enter inside the pipe (in the right side of the image)

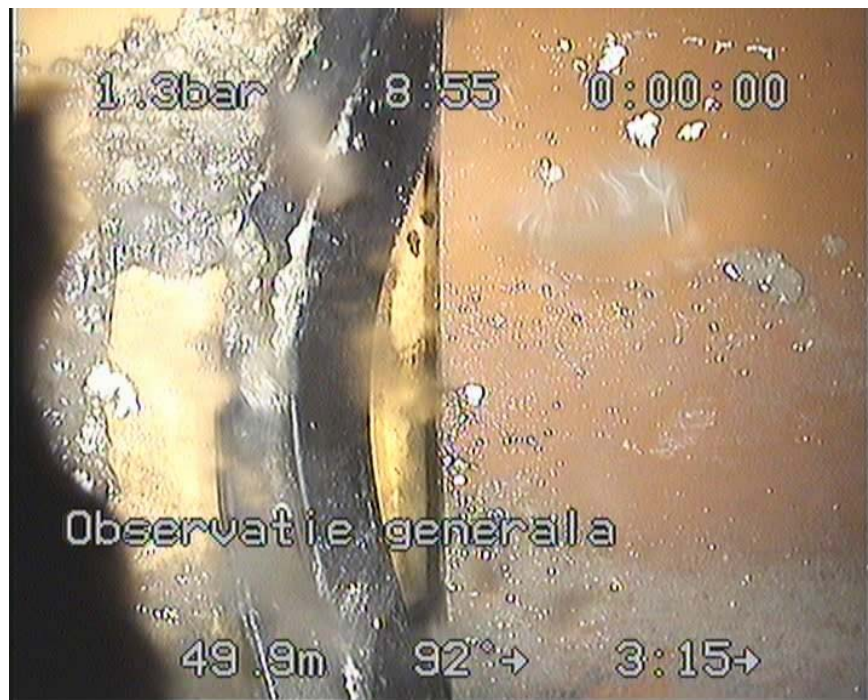
Fig. 3. Rubber gasket expelled from groove in a PVC pipe joint

joint has the gasket expelled and sealing compromised

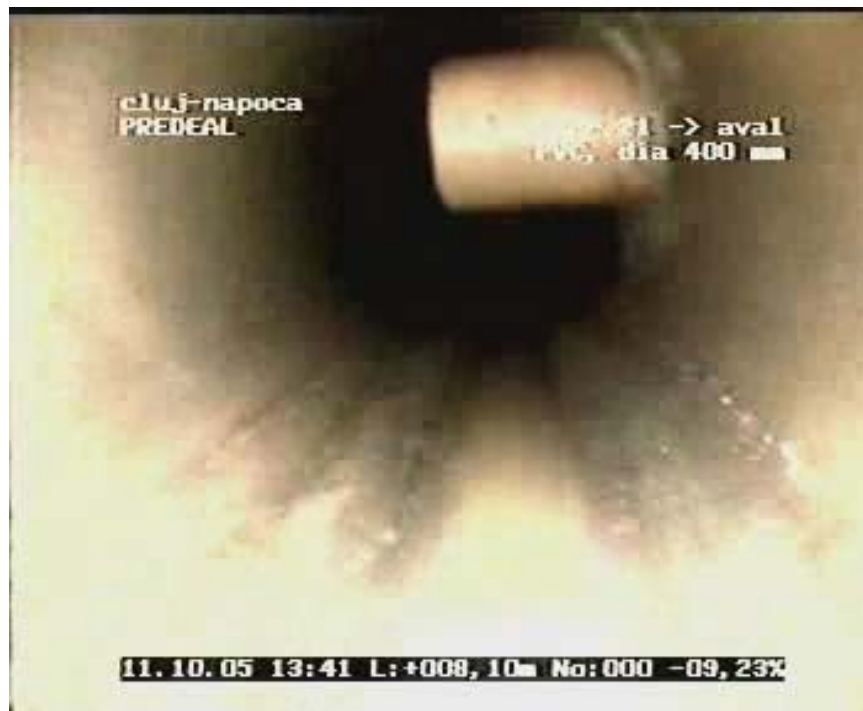
The same problems may occur also at lateral joints but here there is one more situation worth mentioning, namely laterals protruding excessively inside the sewer main. In this particular case is not an issue of compromised sealing but an issue of creating an obstacle in the way of floating debris that may lead to creation of dams inside the sewer section. For example a wooden plank stuck against such a protruding lateral will quickly agglomerate sand and gravel thus creating a sediment deposit and diminish the usable cross section of the pipe. Another issue related to protruding laterals is the impediment of continuing the CCTV inspection when such a situation arises because it acts like a barrier in the way of the inspection robot, the only solution being to try to insert the robot from the

other manhole and this is time consuming. This situation is exemplified in Figure 4. Even more, if we have two protruding laterals between two consecutive manholes the distance between them cannot be inspected.

Fig. 4. *Protruding lateral inside sewer main prevents the camera robot to advance along the pipe [2]*

as possible because thickening of the roots may lead to pipe collapse. There are special cutting heads for removing roots inside the pipe but the tree should also be removed from the vicinity of the pipe line. Protruding laterals can be removed by remote controlled robots equipped with special cutting heads. Minor cross sectional deformation should be inspected on regular bases to see if the deformation is getting worse, in which case the pipe must be replaced. Sever deformation implies immediate replacement of the pipe.

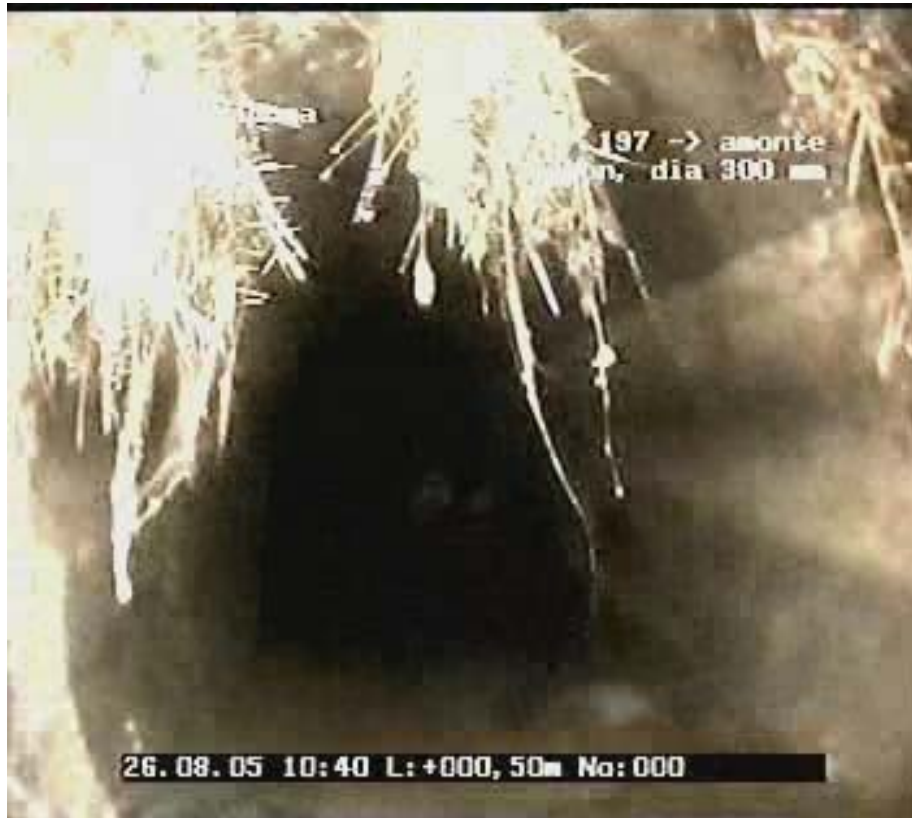
Root penetrations occur when trees exist in the vicinity of the pipe section. Sometimes the trees were planted after execution of sewer pipeline disregarding the minimum distance required by norms. In any case root penetrations inside the sewer pipe may lead even to the collapse of the pipe or complete obstruction of the cross section thus incapacitating the functioning of the sewer. Figure 5 shows a case of root penetrations at an early stage, the sewer section being still in function.

Fig. 5. Early stage of roots penetrating inside concrete sewer pipe [2]

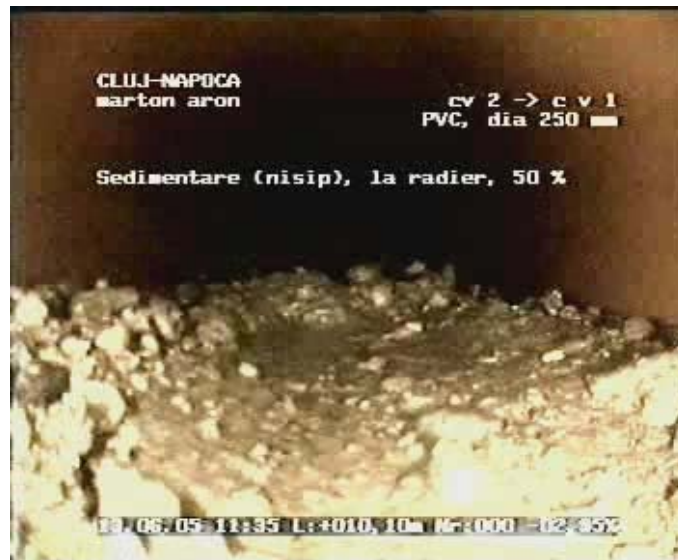
This type of fault has mainly two causes. The first and the most frequent is the lack of a proper pipe slope that leads to a waste water velocity lower than the self-cleaning velocity stipulated by norms. The second cause is the creation of artificial dams inside sewer pipe due to debris stuck across the section. The most problematic is the first case because it can be corrected only by remaking the sewer section and laying the pipe at the correct slope. The alternative, would be to make frequent washes of the sewer section which can be very costly in terms of money and resources. The second situation can be solved comparatively easy by removing the dam inside the pipe

Fig. 6. *Deposits of sediments – 50% of the pipe cross sections is unusable due to sediments*

and performing a wash of the sewer section. In cases of counter slope the deposits of sediments can reach such heights that render the sewer section unusable.

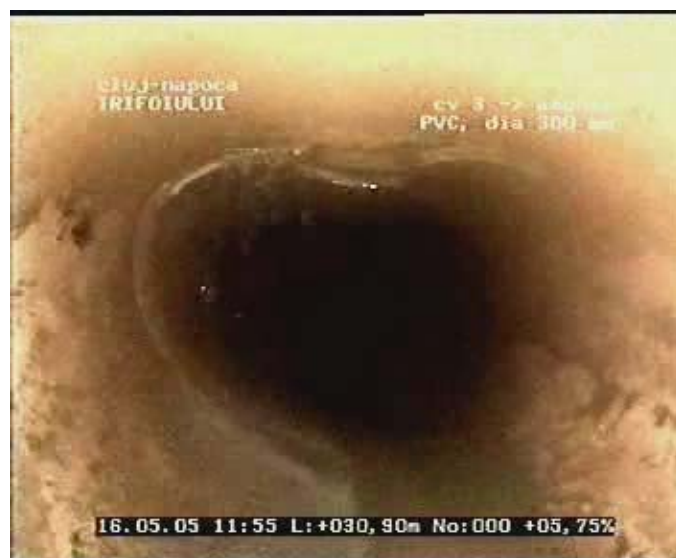
While small ovalities do not affect the functioning of the sewer section as long as the sealing is still maintained severe deformation can go beyond ovality and the cross section of the pipe gets a U shape. In

this case it is obvious that the good functioning of the sewer is prevented and the sealing is lost. Figure 6 shows a case of sediment deposit and Figure 7 presents a case of severe cross section deformation in a PVC pipe.

Fig. 7. *Severe deformation of the pipe cross section – the sealing is compromised*
