REHABILITATION OF A TIMBER TRUSS FROM THE ROOF OF TURDA THEATRE HALL

Abstract: Damages or some local failure of timber trusses used in case of existing buildings are related in almost all the situations to weathering or biological attacks caused from insects and fungi and rarely to aging phenomenon or amplified loads. Strengthening or substitution of some parts of the truss (especially the beam supports) are necessary interventions used to ensure the safety of the structure or to increase its level of performance. In this respect, the paper present the strengthening solution used in the case of a timber truss, for a building located in Turda city. The strengthening solution was consisting in a metal structure fitted to the truss support designed in order to transmit their loads to the lateral load bearing masonry walls.

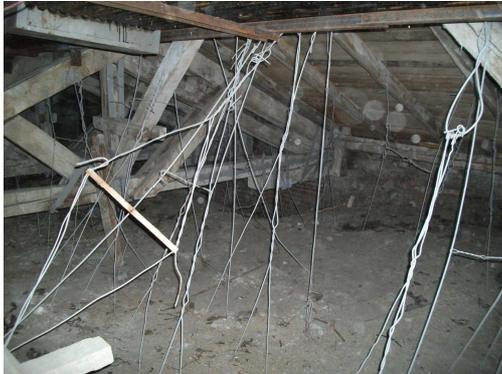
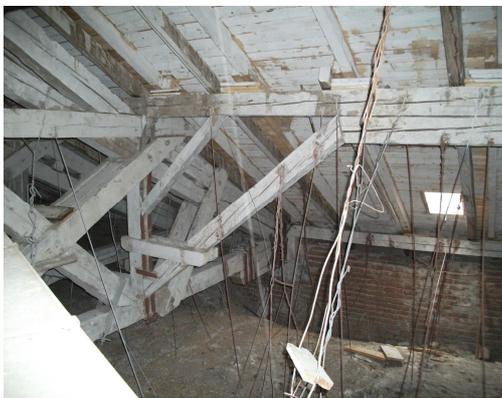
Fig. 3. *Suspended tie- rods*

The over the basement floor has the form of a thin membrane of plasters, cast over a mesh of reinforcing steel of diameter $\varnothing 10$ mm at the between-the-axes distance of about 40 cm. The plaster is suspended to the roof frame with wire tie-rods (Figure 3a, b).

In order to take over the loads transmitted from attic roof were provided purlins between roof trusses in order to sustain rafters. Wind bracing fixed on the inferior part of the truss flange (Figure 3b) were provided to assure bracing in longitudinal direction.

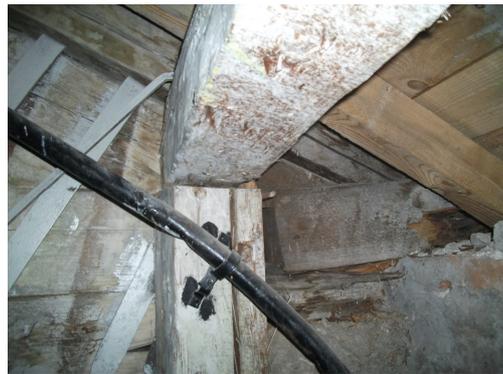
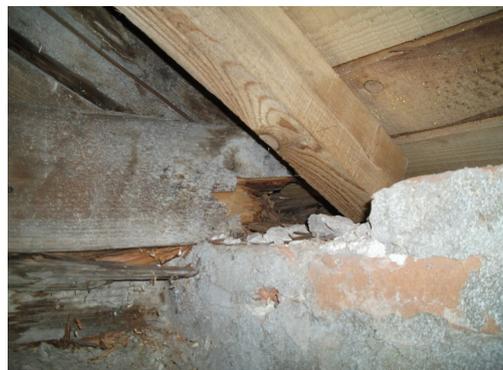
Fig. 4. *Truss failure*

but are mainly determined by the moisture originating in rainfall water and to a lesser extent to the aging of the timber. One end of truss no. 2 from J axis (see Figure 1) got rotten and failed locally, the vertical displacement of the truss support after failure being about 10-12 cm (Figure 4).

It was also found that part of the existing steel elements are displaced, deformed and corroded. Truss no. 2 (from J-axis - Figure 1) had a support that failed and was strengthened probably soon after inauguration.

The vertical displacement of the truss and other members moved together with the former, affected the stress state in the suspended tie rods of the ceiling leading to ceiling cracks.

The advanced state of degradation of the truss support put in danger of collapse

To rehabilitate the truss (the affected beam support area), the study took into consideration the idea of consolidating it's area in the displaced position, as the movement to the initial position would encompass the collapse of the floor and its ceiling decorations.

For the strengthening of the truss flange, a steel structure fitted to the lower end of the truss was used, to transmit the load from the truss to the bearing masonry walls.
