ASPECTS REGARDING DIAGNOSIS AND REHABILITATION OF AN INDUSTRIAL REINFORCED CONCRETE STRUCTURE

Abstract: *Chemical corrosion is the main cause of degradation of reinforced concrete structures with extended operating system in an aggressive chemical environment. As a result of chemical action a significant number of industrial buildings developed and operated in the chemical industry before 1989 suffered pronounced degradation state. The paper treats theoretical and practical aspects related to procedures for investigation, diagnosis and rehabilitation of a concrete structure from dyes platform “COLOROM” Codlea. Rehabilitation solution proposed leads to the restoration of damaged structure capacity to a level 130% higher than that of the undamaged state.*

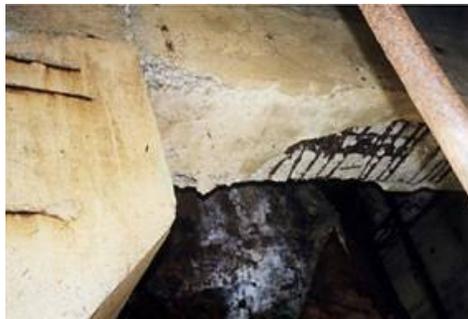
- Concrete surface layer leaching out to a thickness of between 2 and 3 cm;

Fig. 1. “Acid I” Section - Series B, axis 5, +5.50 m elevation, console and beam frame

- Unveiling transverse reinforcing bars and its surface corrosion (Figure 1);
- Reduced thickness of concrete reinforcing bars cover layer;
- Non-uniform distance between the stirrups;
- Lack of basic measures of protection of concrete against chemical corrosion;
- Poor maintenance of the building.

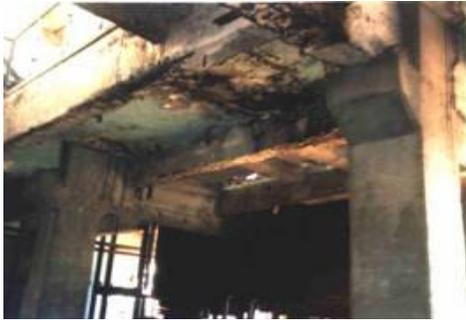
- For columns and consoles:
 - Corroded reinforced concrete bars cover, with opened cracks at approximate (2.5...3) cm distance from the edge;
 - Cracked concrete layer is slightly off when striking with a hammer;
 - Local detachment of the concrete cover, with the highlight of corroded reinforcing bars;
 - The unveiling of the aggregate grain from bonded side and highlighting the area of “rough” concrete;
 - Leaching out of protective concrete on a thick from (2...6) cm;
 - Corroded longitudinal and stirrup reinforcing bars, reducing their section with approx. 30% for columns and about (10...15)% for consoles.
- For slab at +4.80 m elevation:
 - Sections with protected concrete from slab’s intrados exfoliated (Figure 2);

Fig. 2. "Intermediaries B" Section - Floor degradation at +4.80 m elevation, series B-C, axis 4-5

- Corroded floor ribs with longitudinal cracks in the concrete cover at a distance of approximate (2...3) cm from the edge (Figure 2);
- Protection concrete separated on parts from the beams and unveiling of reinforcing bars (Figure 2);
- Corroded reinforcing bars from degraded or fallen protection concrete areas and highlight the section bars reduction with approximate (20...30)%;
- Protective concrete leaching out on (2...4) cm thickness;
- Most affected areas are those around production tanks crossing holes.
 - For roof's floor:
 - Corroded concrete from coffer's slab intrados, with visible mesh of reinforcement;
 - Coffers with strong damaged ribs by cutting of longitudinal reinforcing bars and reduction in certain areas of the rib section in proportion of 50%;
 - Corrosion of reinforced concrete beams and attic;
 - Concrete roof elements leaching out, on a thickness of (2...7) cm.

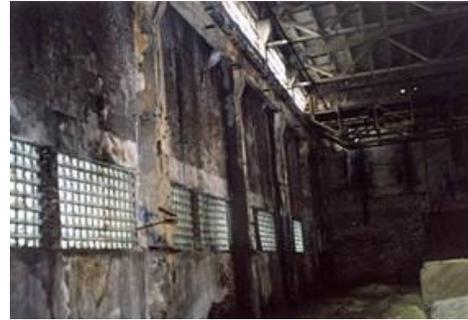
Fig. 3. "Sulfur storage" hall overview

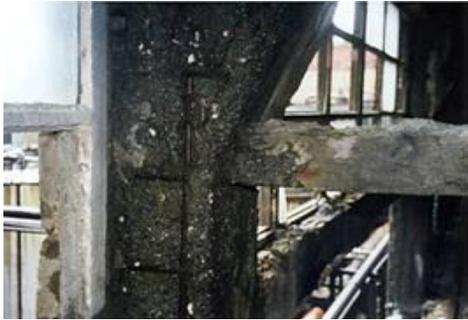
- Concrete leaching out on a (1-5) cm thickness range;
- Carbonation products erosion from the surface layer of concrete and highlighting (unveiling) aggregated granules (Figures 2 and 3);
- Presence of surface and in-depth cracks on columns and consoles faces, specific to sulfating corrosion (Figure 4);
- Cracks orientation towards disposition direction of reinforcing bars;
- Local detachment of the reinforcing bars cover;
- Unveiled reinforcing bars corrosion;
- Insufficient thickness of concrete reinforcing bars cover;
- Use of metal spacers for maintaining the position of reinforcing bars instead of plastic or cement mortar;
- Excessive moisture in the concrete columns due to water seepage from the roof;

Fig. 4. "Sulfur storage" - Column and bracket, series A, axis 2

- Lack of concrete protection against corrosion.

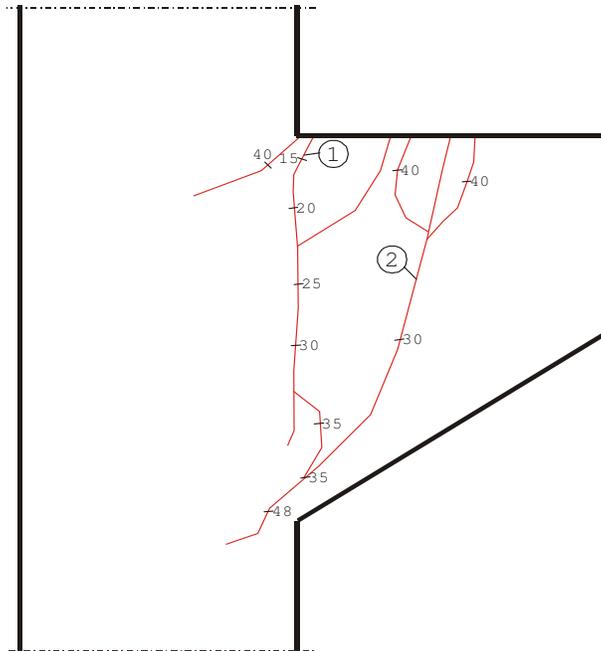
For consoles, CS 1-1, CS 1-2, CS 1-3 (tested to failure), their breakdown has occurred at a force of 48 tf for consoles CS 1-2, CS 1-3 and 50 tf for CS 1-1 console.

Cracks appearing and development (Figure 5) show that they occur in number from two to three, which then spreads into new crack, smaller in terms of length and opening.

Fig. 5. CS-1 console mapping cracks

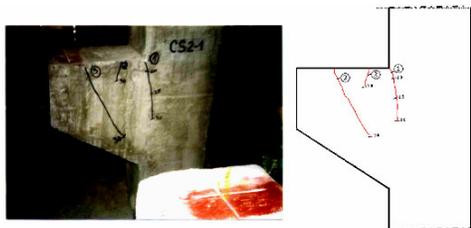
The first cracks appear, in all cases, at the joint point with the column, under a load of 15 tf.

Second crack occurred at a strength test value of 25 tf console, except CS 2-1 and CS 2-2, at which cracks occurred in 30 tf and 20 tf, respectively. Crack is observed for all three consoles to load 30 tf.

Second crack is usually located between the first and the third and is less developed than those, not going beyond the top half of the height of the console.

The third crack starts under the metal plate support or adjacent to it, reaching an

angle of about 45° at a distance of approx. (1...34) cm from the lower corner of the console-column junction. The map for CS 2-1 console cracks appearance and development is shown in Figure 6.

Fig. 6. CS 2-1 console mapping cracks

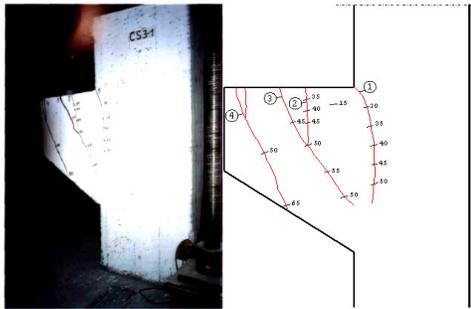
- Presence on the side of the console of a 4 to 5 main breaks;
- First crack appears in the console-column junction for all consoles, at a vertical load of 30 tf for CS 2-1; 20 tf for CS 2-2 and 25 tf for CS 2-3;
- Other cracks are inclined (about 45°),

start under or adjacent to the support plate and develop the height of the console;

- Console failure occurred at a vertical load of 69 tf for CS 2-2 and 70 tf for CS 2-1, CS 2-3, by opening and cracks spreading and crushing concrete from the main column supporting the console (Figure 7).

Fig. 7. CS 2-1 console mapping cracks (consolidated)

The 8 cm thick reinforced concrete coat includes both console and column area to which is bounded.

After prior preparation of experimental models surface (by roughened and washing with running water) - models tested in the first phase up to 30 tf load - the reinforcing bar case was introduced and fixed in position through metallic spacers, then formwork and C16/20 concrete class pouring was made.
