UNCONVENTIONAL CULTURAL HERITAGE - CONSERVATION OF BRATEIU CART FROM ASTRA MUSEUM

E. BELDEAN¹ M.C.TIMAR¹ A. VARODI¹
V.OLARU²

Abstract: *The paper refers to the conservation-restoration of an interesting and certainly less conventional artefact from the collections of Astra Museum. This was one of the objects restored by a team of 13 volunteers from the Faculty of Wood Engineering, of Transilvania University in Brasov, during the restoration camp 13 for Astra. The object was the cart from Brateiu, Sibiu County, a one horse drawn cart, dating from the end of XIXth century. The object with a complex construction including wood and metallic elements, though in a fairly good conservation state, needed interventions such as: cleaning, curative and preventive biological protection, consolidation of frail wood, restoration of metallic elements and minor completions and chromatic integration. The restored object was exhibited in Sibiu and Braşov.*

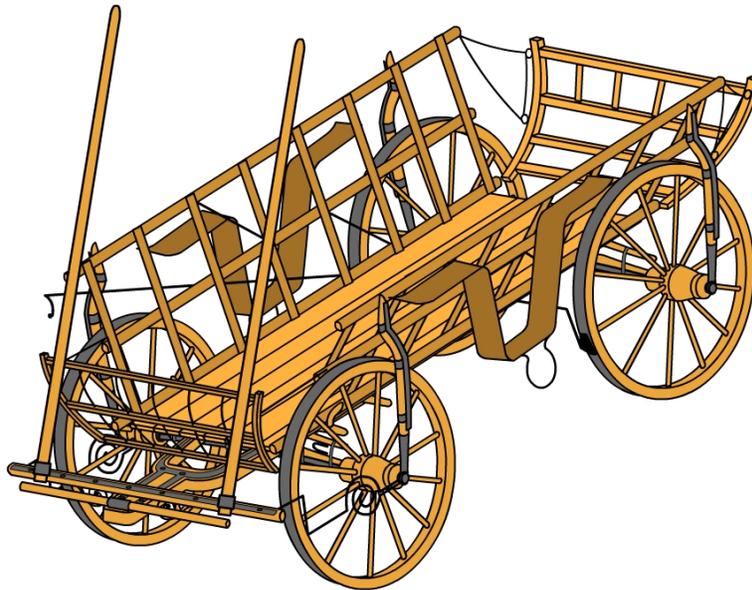
Fig.1. *The cart from Brateiu from the collection of ASTRA Museum – general view (original drawing)*

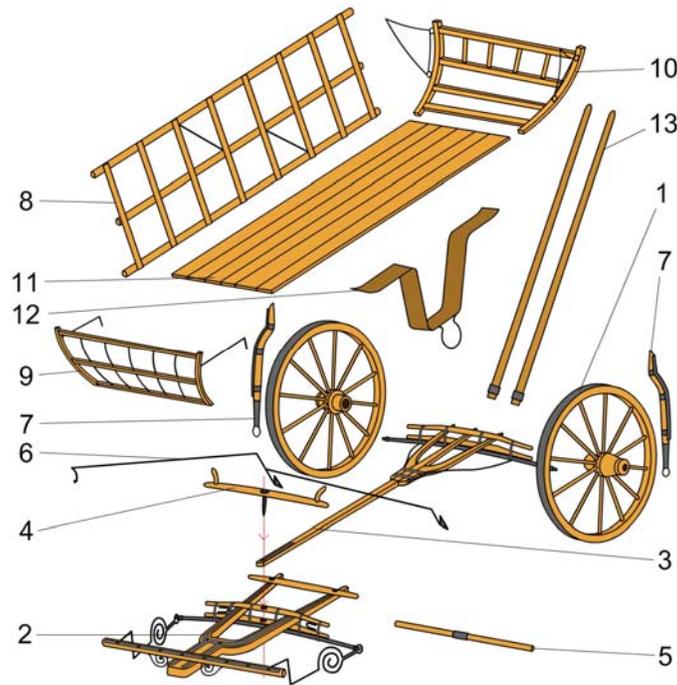
Fig. 2. *The main components of the Brateiu cart (original drawing)*
 1-Wheel (made of axle, spokes, rims, iron plates), 2- Running gear, 3- Rear axle,
 4-Wooden rod, 5- Horse hitch equipment (cross), 6- Manual brake, 7- Curved strong
 element, 8- Lateral framed part of the body, 9-Front part of the body, 10- Backside of the
 body, 11- Wooden platform, 12- U-shaped stair, 13- Front round wood

Figure 2 presents an exploded view of the cart highlighting its main elements, noted from 1 to 13.

Beneath the cart body is the *undergear* or *undercarriage*, consisting of the running gear and chassis. The wheels and axles, in distinction from the body, are the *running gear*. The wheels revolve upon bearings or a spindle at the ends of a bar called an *axle*. Front wheels are smaller than back wheels and they are streaked with iron, a method of nailing iron plates onto the rims to protect against wear on the ground and to help bind the spokes together (1).

The cart has two axles. On this solid four-wheeled vehicle, the forward part of the *running gear* (2) is arranged to permit the front axle to turn independently of the fixed *rear axle* (3). Several structural members form parts of the *chassis* supporting the carriage body. The front axle and the splinter bar above it are joined by metal elements. To strengthen and support, a *wooden rod* (4) with two lateral leaning parts fixes the end of the rear axle to the running gear by a big iron nail [<http://en.wikipedia.org/wiki/Carriage#Body>]. The body comprises five distinct parts (8 right/left, 9, 10, 11). On the lateral parts there are *two framed grid elements* (8). On the front part and backward there are *two curved elements* that close the body and are fixed by lateral parts with iron chains or hooks. The *backside* (10) is bigger than *front side* element (9). A *wooden platform* is placed on chassis as a floor of the cart (11). On lateral places *curved strong elements* (7) fixe the body with axles. *Two U-shaped stairs* with metallic steps facilitate the climbing into the cart (12).

A system of *manual brake* (6) that work on the back wheel is fixed on the right part.

In front of the cart there is attached a *horse hitch equipment* comprising a *cross*

(5) and *two long round woods* (13) that are hung on the running gear.

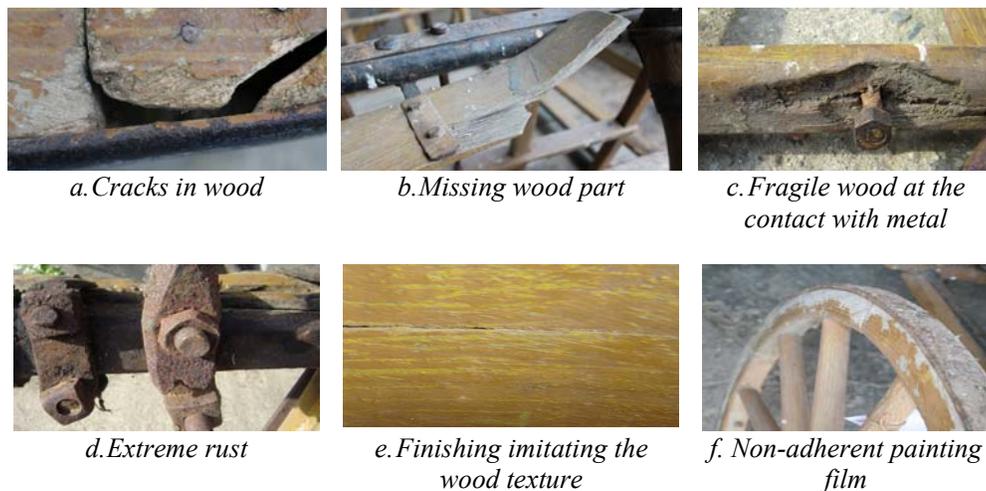
Wood degradation (fungal decay leading to wood softening) and deterioration (cracks, ruptures, missing parts) were present mostly at the wheels, due to the intense use and sustainment of the entire weight of the cart (Figure 3a, 3b). Signs of wear and tear were also present, but considering the oldness of the artefact and conditions of utilization and storage, it could be said that wood was in a fairly good condition. Areas with fragile wood were also observed on the lateral parts, at the contact with metallic parts or beneath them, due to water retention between the wood and metal reinforcements (Figure 3c).

Metal parts had serious problems of corrosion (Figure 3d). Following exposure to degradation factors, most of the elements had a thick layer of rust. The screws were corroded and very difficult to be removed. Signs of wear as result of intense use were also identified.

observed, because the finishing layer was not identical for all the elements. The original finishing layer, in two colours (yellow and brown) imitating the wood texture (Figure 3e), alternated with areas of opaque ochre paint. The original finish was still preserved on the wheels, stairs, lateral parts, back and front parts of the cart (Figure 3e), though serious adherence problems and film losses were obvious (Figure 3f).

Fig.3. *Most frequent defects present on the object before restoration*

A very difficult problem was to remove severe rust from metal elements. Mechanical and chemical methods were used for cleaning. Therefore, the metallic surfaces were cleaned using scratch brushes and a chemical solution Evipass, followed by brushing, water cleaning and drying. The operation followed the principle of patina conservation, so that cleaning was stopped before obtaining

completely clean and shiny surfaces. All metallic elements of the cart were similarly treated against corrosion. In order to prevent further rusting, a final treatment with graphite black powder in a solution of Paraloid B72 (solution 2% in ethyl acetate) was applied. This also gave a nice grey aspect to the metallic elements. (Figure 5)

Wooden parts required specific operations. The conservation-restoration schedule included generally common operations such as: dust and dirt cleaning, curative preservation, consolidation of fragile wood, gluing of cracks and ruptures, completing the missing parts, preventive preservation and finishing.

Cleaning operation started with dust removed by brushing and continued with wet cleaning employing a water solution of neutral soap C2000 with ethyl alcohol and ammonia. After drying, the surfaces were gently sanded and the non-adherent finishing paint was removed. The next step in conservation was the curative preservation against insects attack. A repeating treatment with solution of Per Xil 10 was employed by injecting into the galleries. After conditioning, the frail wood was consolidated with Paraloid B72 (solution of 5-6% in ethyl acetate) and repeated until the timber was consolidated and saturated.

The gluing of cracks, broken parts or completing parts was made using rabbit-skin glue 30%. Wooden strips were used to fill the large cracks after a previous cleaning of surfaces by sanding and wiping out with ethyl alcohol. The missing part from the right stair and the vertical element of the back side were completed (Figure 4).

These new elements were chromatically integrated in the context of the old object with tempera colours. A preventive treatment with Biotin (fungicide) was applied on the whole the wooden surfaces, followed by beeswax finish to obtain hydrophobic and aesthetical surfaces.

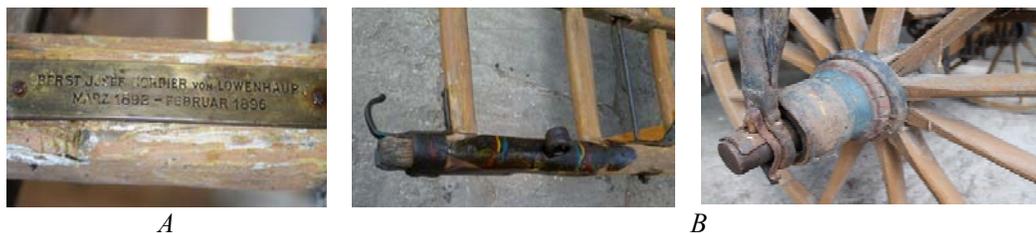
The Romanian flag colours appear on metallic elements and on the axles of the wheels (Figure 4 b).

in German language (Figure 4a), the signs of Romanian identity are obvious and could be related to the historical evolution of Transylvania.

Fig. 4. *Evidence of history and identity (a- German inscription, b- colours of Romanian flag painted on metal and wooden parts)*

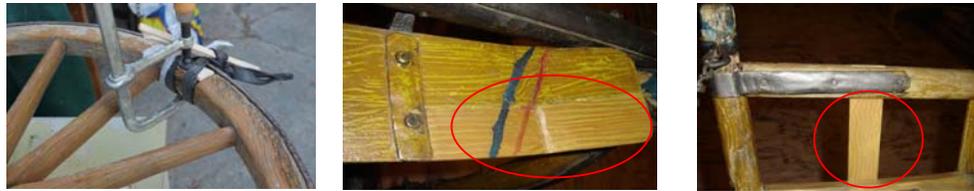
Fig. 4. *Gluing and completing the missing parts*

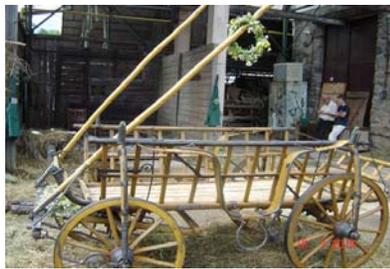
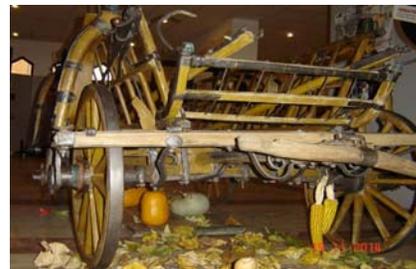
After complete restoration the elements were reassembled and the cart was reconstituted. An image of restored object

is presented in Figures 5 a, b, alongside some details of restored wooden and metallic parts (Figure 5 c, d).

Fig.5. *Brateiu Cart after restoration exhibited in Sibiu (a) and Braşov (b) and details of restored wooden (c) and metallic elements (d)*
