THE ANALYSIS OF ROAD TRAFFIC ON CALEA UNIRII STREET IN SUCEAVA CITY

Abstract: *There was conducted a short-term census to determine the service level and circulation capacity of the intersections located on the Calea Unirii street at km 4 + 980.00 (Iulius Mall intersection), km 5 + 651.00 (Dedeman intersection), km 6 + 720.00 (Burdujeni). It was determined the instantaneous speeds at peak hour in the busiest quarter of an hour on the part of the street between pedestrian traffic light controlled crossings. Below we are presenting the results obtained.*

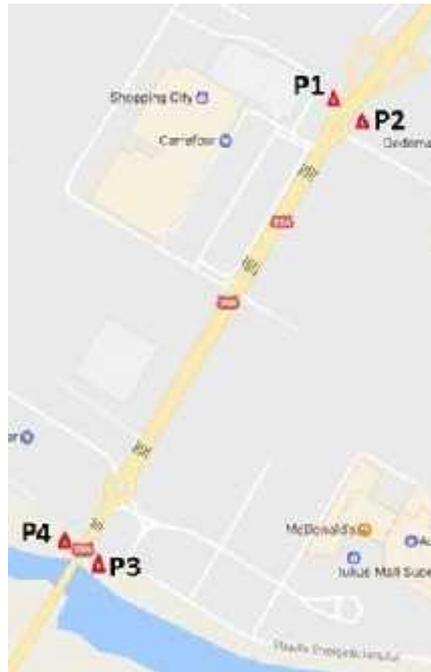
Fig. 4. Image of the four review posts were located

The short-term census lasted for 3 days. In each day, the traffic was reviewed in four posts for 14 hours a day from 07:00 to 21:00. Review posts were:

- post P1-km 5+700 - direction Burdujeni - Suceava (at the base of the overpass);
- post P2-km 5+700 - direction Suceava - Burdujeni (at the base of the overpass);
- post P3-km 4+870 - direction Suceava - Burdujeni (at the end of the bridge over the Suceava River - at the bazaar);
- post P4-km 4+870 - direction Burdujeni - Suceava (at the end of the bridge over the Suceava River - at the bazaar).

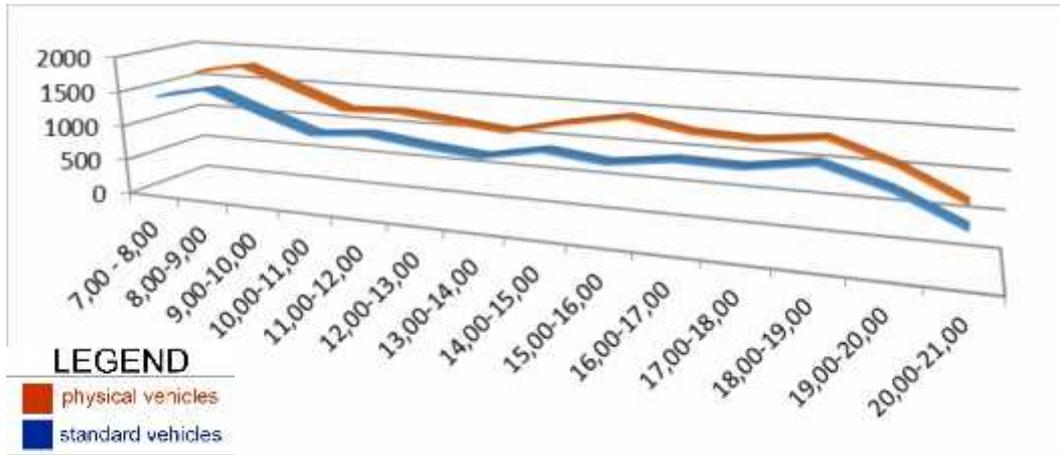
Fig. 5. Image of the traffic distribution in post P1 - Lane 1 + Lane 2

The figures 5, 6, 7, 8, 9, 10 show the distribution of traffic reported by hours in the P1, P2, P3, P4 posts in physical and standard vehicles.

In the P1 post, in the direction of Burdujeni - Suceava (Lane 1 + Lane 2) the peak time is 8:00 - 9:00 with a traffic in physical vehicles of 1562 pcs. and 1766 pcs. in standard vehicles.

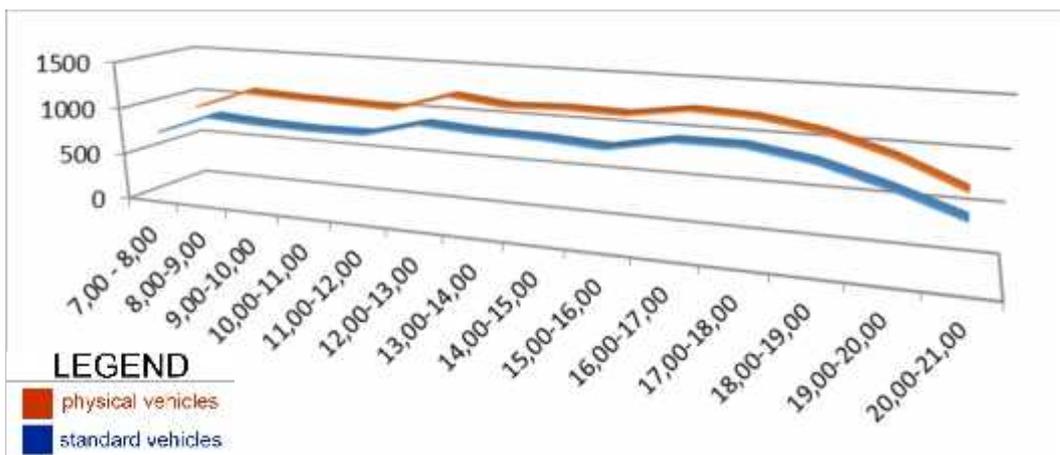
Fig. 6. Image of the traffic distribution in post P2 - Lane 1 + Lane 2

In the P2 post, in the direction of Suceava - Burdujeni (Lane 1 + Lane 2), the peak time is 17:00 - 18:00 with a traffic in physical vehicles of 1075 pcs. and 1237 pcs. in standard vehicles.

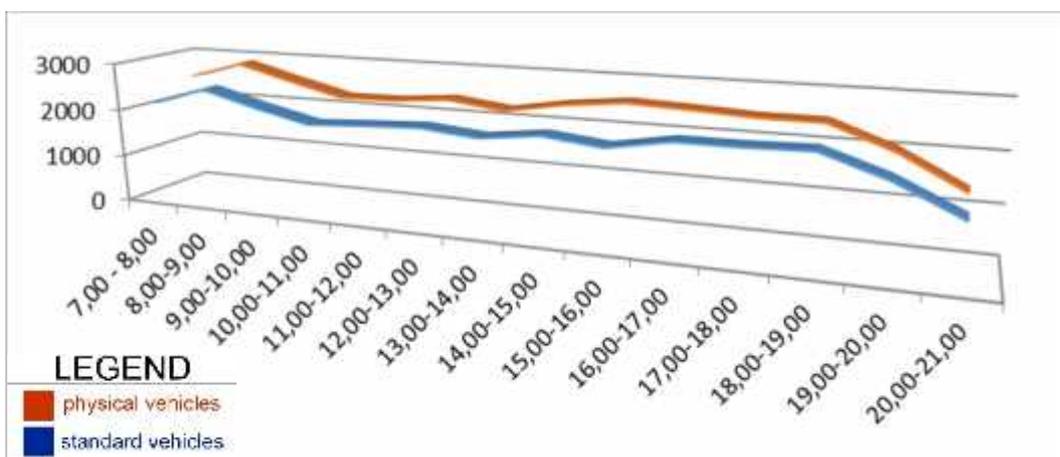
Fig. 7. Image of the traffic distribution in post P1 + P2

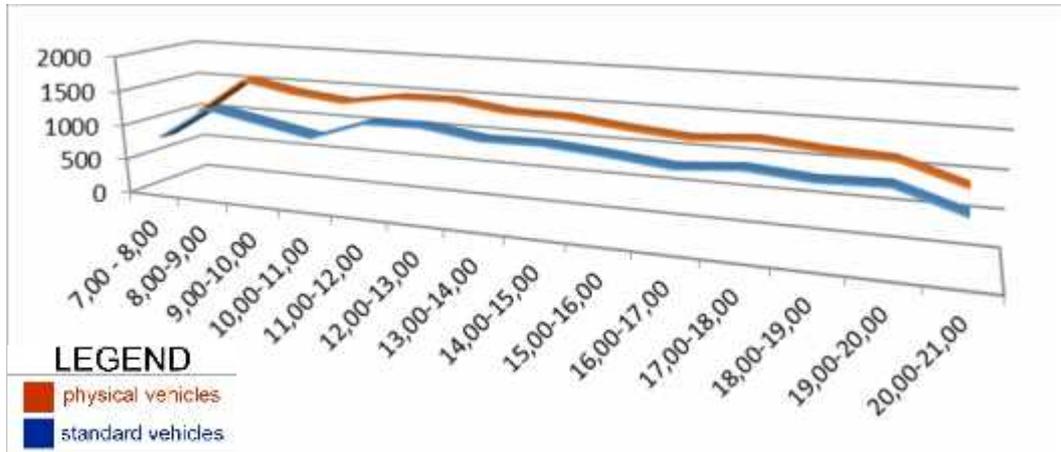
Fig. 8. Image of the traffic distribution in post P3 Lane 1 + Lane 2

In the P3 post, in the direction of Suceava - Burdujeni (Lane 1 + Lane 2) the peak time is 8:00 - 9:00 with a traffic in physical vehicles of 1278 pcs. and 1547 pcs. in standard vehicles.

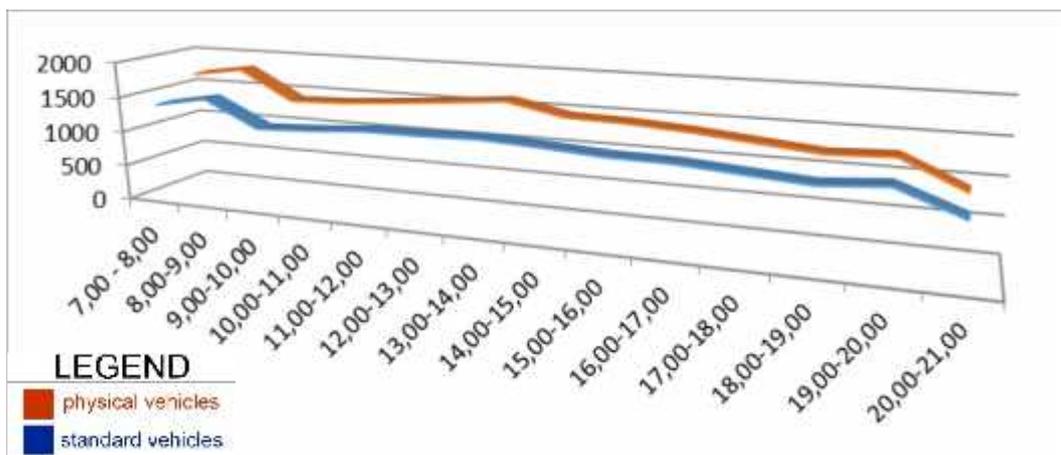
Fig. 9. Image of the traffic distribution in post P4 - Lane 1 + Lane 2

In the P4 post, in the direction of Burdujeni - Suceava (Lane 1 + Lane 2) the peak time is 8:00 - 9:00 with a traffic in physical vehicles of 1513 pcs. and 1802 pcs. in standard vehicles.

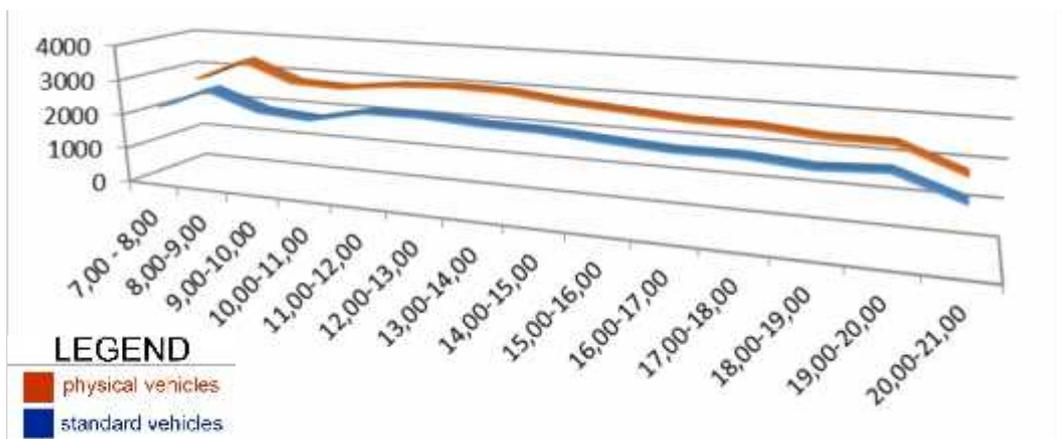
Fig. 10. Image of the traffic distribution in post P3 + P4

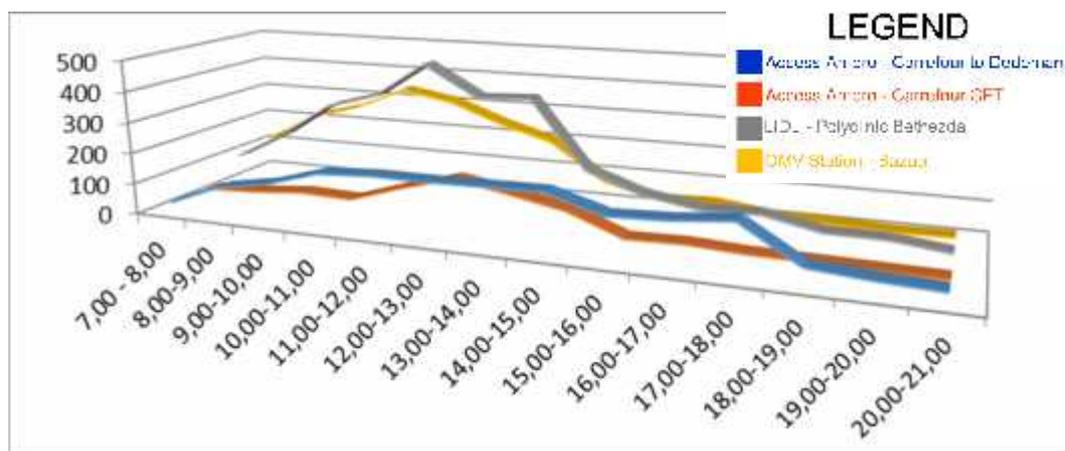
There was conducted a census for the number of pedestrians at the four pedestrian crossings on the Calea Unirii Street, the traffic evolution is shown in Figure 11.

Fig. 11. *Image of the number of pedestrians*

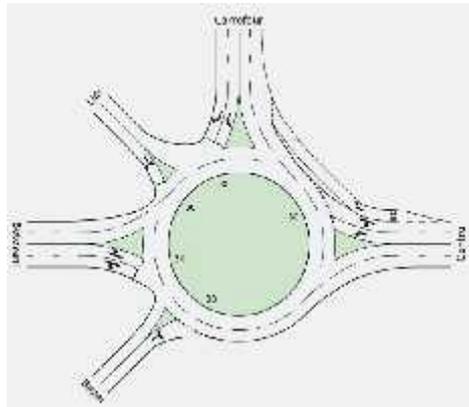
The schematic representation of the Iulius Mall roundabout is shown in Figure 12.

Fig. 12. *Image of the Julius Mall roundabout.*

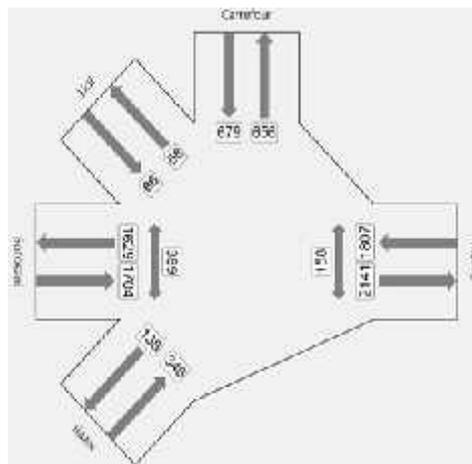
The traffic values on the circular ring of the intersection are shown in Figure 13.

Fig. 13. *Image of the traffic values on the circular ring of the intersection.*

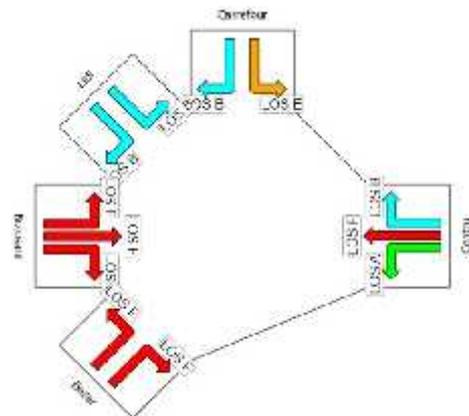
Service levels for each direction are shown in Figure 14.

Fig. 14. *Image of the service levels for each direction*

In the current configuration, the studied intersection had reached and exceeded the maximum level of service (service level F, which represents that the traffic delays for more than 50 seconds, the road traffic in the intersection area is difficult especially on the Burdujeni – Suceava / Suceava - Burdujeni, respectively to Combucoovina), which is why frequent traffic jams will occur. Therefore, it is necessary to study the alternatives that support local traffic.

The roundabout at Iulius Mall has the service level "F" that is not functional and measures must be taken to divert traffic and eventually to prohibit heavy traffic.

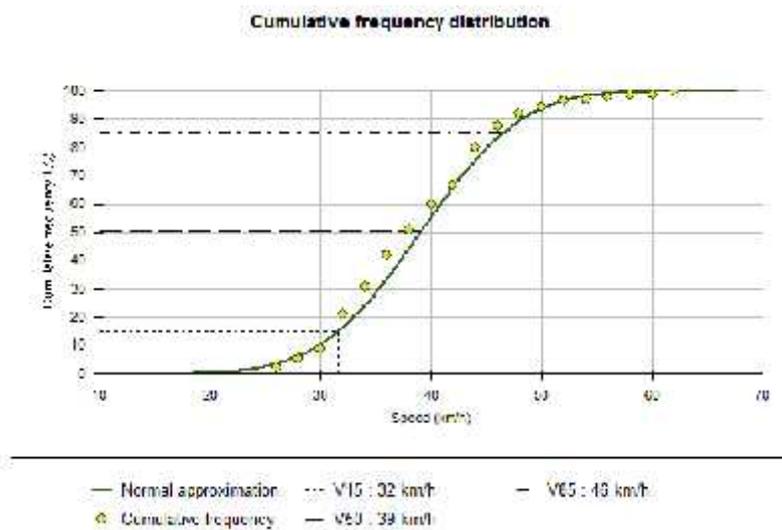
In the direction of Burdujeni – Suceava, between Ambro - Carrefour and the Iulius Mall roundabout is presented the speed diagram in figure 16.

Fig. 16. Image of the speed diagram in the direction of Burdujeni – Suceava, between Ambro - Carrefour and the Iulius Mall roundabout.

It can be noticed that on the three speed-determining sectors where no traffic jam has occurred and the velocity values are significantly equal.

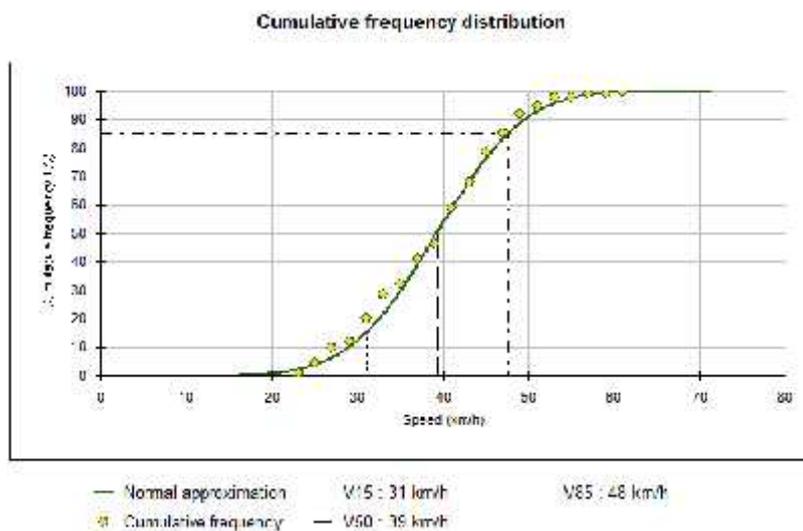
In the direction of Suceava – Burdujeni, between the Dedeman roundabout and Ambro – Carrefour access is presented the speed diagram in Figure 17, resulting in speeds.

Fig. 17. Image of the speed diagram the direction of Suceava – Burdujeni, between the Dedeman roundabout and Ambro – Carrefour access.
