ANTISEISMIC STRENGTHENING OF COMPOSITE STEEL-CONCRETE SHEAR WALLS USING HIGH PERFORMANCE STEEL FIBER REINFORCED CEMENTITIOUS COMPOSITES

V. TODEA¹ V.A. STOIAN¹ D. DAN¹ S.C. FLORUȚ¹
D.A. POPESCU¹

Abstract: *The present paper describe the nonlinear behaviour of composite steel-concrete structural walls, under lateral loads, applied in a cyclic loading procedure, simulating the effect of an earthquake, which were tested initially up to full failure and after then, strengthened using a high performance steel fiber reinforced cementitious composite material and retested to full failure, being described aspects such: sectional configurations and geometry of tested elements, materials used and also the results obtained from the tests carried out in laboratory.*

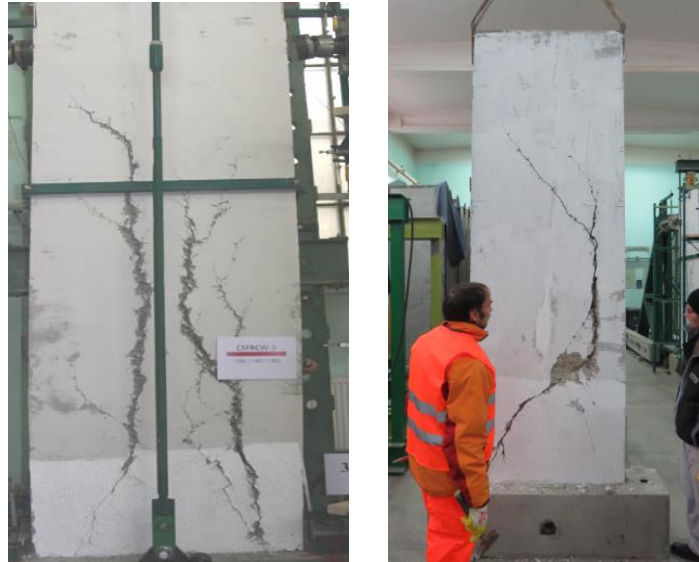
Fig. 3. Encountered type of failure - CSFRCW group of specimens - shear failure

The main objective of the research performed on the CSFRCW group of specimens in initial case, was to investigate if the traditional reinforcement placed in the central part of walls could be successfully replaced by the steel fibers, with a similar percentage of embedded steel fibers mixed in the concrete core of the wall [2,3]. The experimental tests, leads, to the conclusion that the concrete steel fibers mixture, was not able to supply the tension resistance of the missing traditional reinforcements, tested specimens developed brittle failure modes. All the specimens reached the failure at a maximum value of drift, 30-40 mm. Failure was triggered by central diagonal splits, characteristic to shear failure modes. Specimens shown a low rate of dissipated energy. This kind of behaviour is not recommended in the seismic areas. At the end of the tests, the specimens showed an advanced state of degradation as are illustrated in Figure 3.

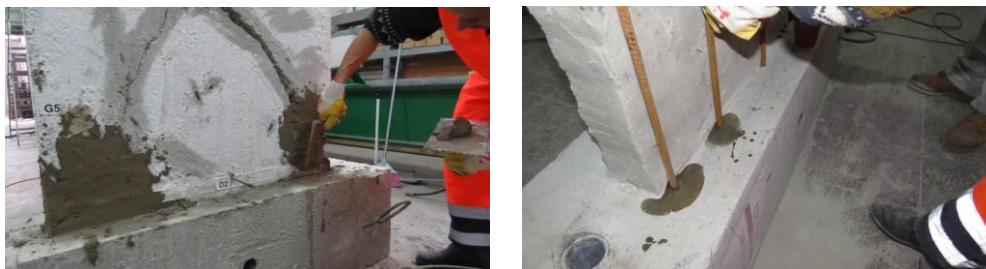
Fig. 4. Phases from strengthening procedure - inserting steel rods and repairing the damaged concrete with high performance repairing grouts

Strengthening procedure was performed in two different phases, in the first one, a preliminary repair of the specimens was made. Damaged concrete zones were removed and remade with a new high strength repairing mortar, the small cracks were filled up by injecting liquid epoxy resin and the surface of the wall was mechanically prepared, to assure the adhesion of the new material. The second phase consisted in jacketing of the specimens using the HPSFRCC material. The strengthening consists in applying a 25 mm thin jacket of the material on the entire perimeter and height of the walls. The material was cast gravitationally into a classic formwork. The mixing formula of the HPSFRCC material consist in introducing of 1.625 kg of brass-coated steel fibers in 25 kg of grout powder using maximum 3.20 litres of water. The recommended time for mixing the components was between 10÷12 minutes. The structural connection of the HPSFRCC jacket with the concrete foundation block was ensured by chemically anchored steel rods (5 bars of 12 mm diameter) which were distributed on the two long sides of the walls. Rods had 600 mm length, 100 mm inside the foundation and 500 mm outside of it and were made from S355 (fyk= 355 MPa) steel grade.

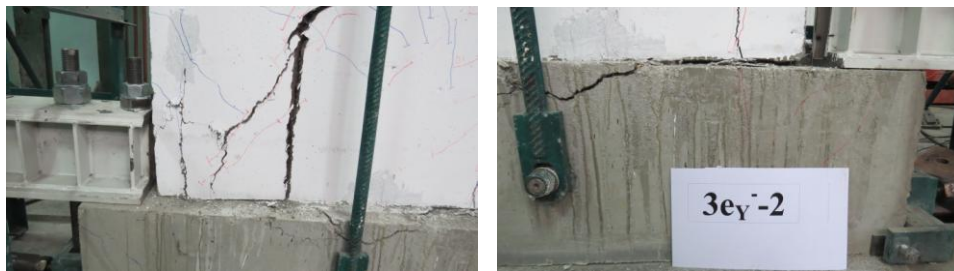
Fig. 6. Level of damage encountered in beam foundation and at the base of the wall

After strengthening and retesting to full failure, shear wall reveals a better behaviour in comparison with initial situation, with an increased rate of dissipated energy and yielding in tension of the encased steel profiles, before the failure of specimen encountered. Was encountered also local damage on the beam foundation.

Tested specimen develops many cracks oriented in a random direction, being multiple on the area of the wall with spread propagation. Cracks was monitored on opening and marked on each step of loading. The visible cracks started developing only at 15 mm level of drift and at a distance of 15 cm from the edge of the wall (which correspond to the internal face of the steel profile and vertical bars) then extending to the centre, forming a group of inclined cracks, on the first 20 mm level of drift, with a maximum $0.15 \div 0.20$ mm value in opening. This fact shows that the jacket is active from the first cycles of loading helping with the overall dissipation rate of induced energy.

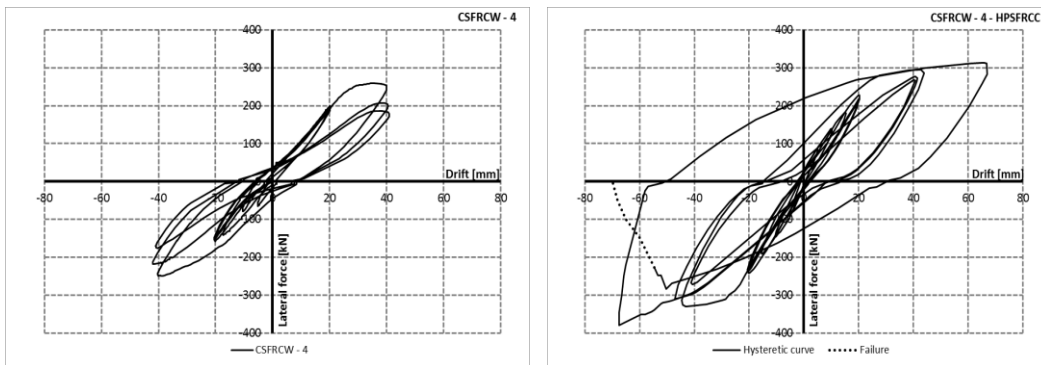
Fig. 7. Hysteretic curves of tested specimens - before / after strengthening

Before strengthening the elastic limit of the wall was reached at 21.84 mm value of drift, 195.8 kN value of lateral force, while after strengthening, at this level of induced force, wall behaviour curve keeps the slope of an elastic behaviour. Chemically mounted steel rods completed the transfer of stresses from the jacket of HPSFRCC into the foundation beam of the wall. After the elastic limit was reached, on the initial situation, existing cracks lead to a brittle failure of the steel fiber reinforced concrete, stiffness of the wall being reduced drastically for the last two cycles of loading. The strengthened wall failed in the same manner (shear failure), but at a higher value of drift and lateral force. The failure diagonal crack of strengthened specimen had another path than the initial situation, revealing that the HPSFRCC jacket had good bond to the fiber reinforced concrete. The behaviour of both specimens under the loading procedure could be better observed by studying the hysteretic curves (Fig. 7).

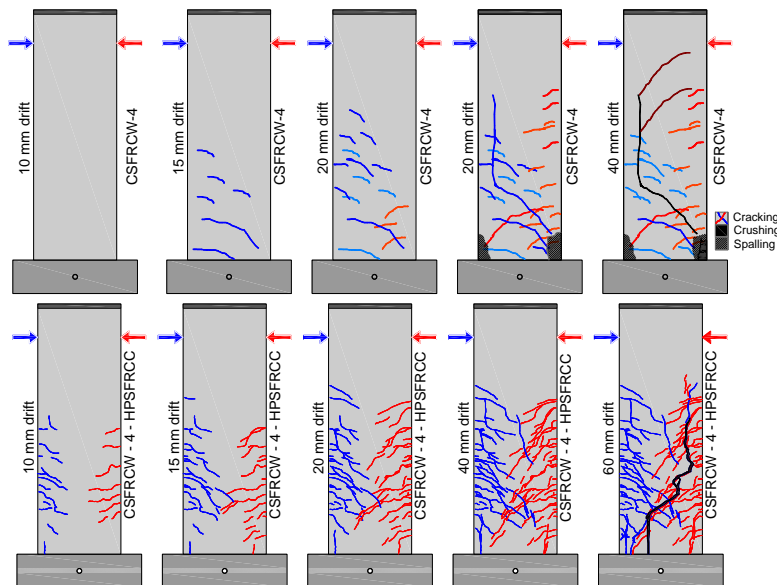
Fig. 8. Behaviour of the tested specimens before / after strengthening
