## CASE STUDY: CONSOLIDATION OF THE A10 SEBEŞ - TURDA MOTORWAY ON THE SLIDING SLOPE SECTION BETWEEN KM 62 + 180 - KM 62 + 460

**Abstract:** *The construction and development of transport infrastructure in Romania is a goal that cannot be achieved yet. Given the diversity of factors that interfere with the building of the national transport infrastructure, the causes of its deterioration are implicitly just as complex and are involving further costs, which more often than not will cause several times increase in the final construction cost. This article describes in detail the methodology applied for the consolidation works executed for Lot 4, road section 4, km 62 + 300, of the Sebeş-Turda motorway A10, where the road infrastructure has started to deteriorate due to the unstrutted excavations carried out up on the slope for the relocation of the medium voltage pole and the final shaping of the embankment for lane 2, where a land subsidence zone has appeared, which stretches beyond the boundaries of the expropriated land.*

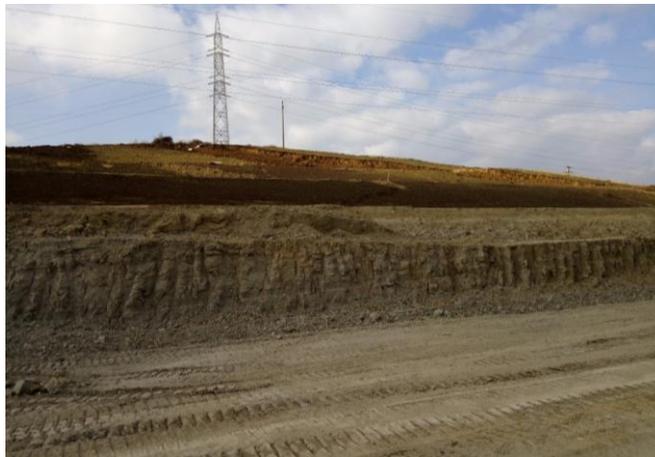
Fig. 1. *Landslide due to Loss of Stability*

During the construction works carried out on the Sebeş-Turda Motorway, Lot 4, sector 4, km 62 + 300, the land has subsided before the relocation of the medium voltage pole and the final shaping of the slope for lane 2 (Figure 1), causing a wide crack that stretches beyond the boundaries of the expropriated land. The land subsidence site has been constantly monitored and the conclusion is that its size has not increased in the period March-July. However, in early August, stability loss phenomena have become apparent across the entire embankment and in the motorway platform area.

From the analysis of the results of the technical expertise, the drilling records, the fact sheets and the laboratory analyzes, it results that these works have significant degradations such as horizontal displacements, vertical cracks and advanced degradations that have left some works, requiring checks at the ultimate limit state, restoration and consolidation under a new project (Figure 1).

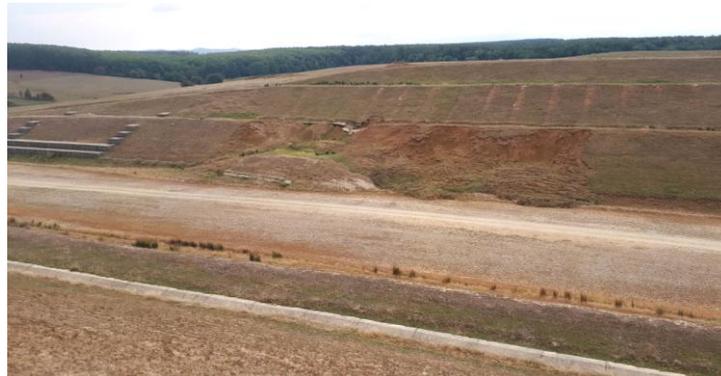
Fig. 2. Geoelectrical Survey Area

On site, in addition to the geotechnical borehole drilling, a total of 16 geoelectric profiles have been prepared, to determine the physical properties of the lithological structures in the study area.

The geoelectric survey has provided an overview of the slope structure, from which the following conclusions have been drawn:

- Highly conductive areas associated with underground water accumulations, in the form of reservoirs developed along a network of cracks, causing geological structure displacements.
- Highly resistive zones associated with massive lithological bodies, with a poorly developed crack network and low moisture content. These areas might react as sliding planes for the overlying structures.

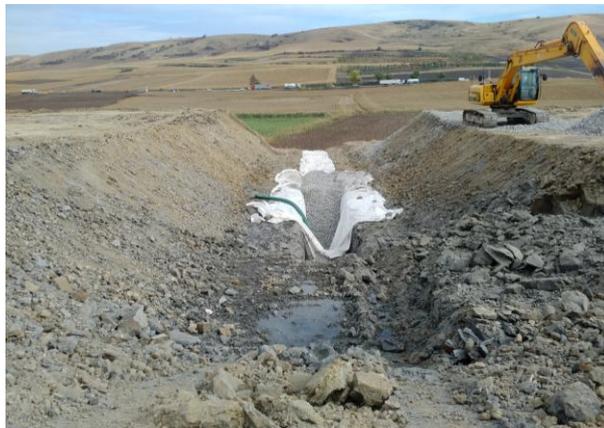
Fig. 3. *Drains*

- A drainage system, built transversally to the motorway, consisting of deep drains laid down at spacing of 25 m inter-axis, across the motorway section stretching from km 62 + 200 to km 62 + 450 (Figure 3);

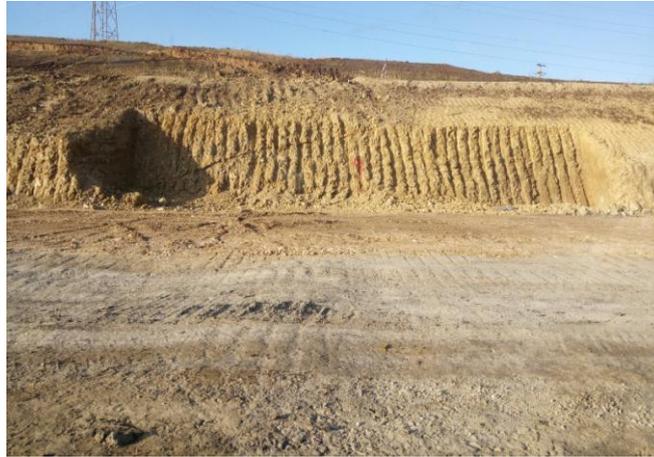
Fig. 4. The sliding plane line

- A 3,00 m high abutment wall, MacMineral type, built on the foundation slab (invert), between km 62 + 240 and km 62 + 432 (Figure 4);
- A discontinuous abutment system consisting of large diameter concrete columns (1200 mm) laid on the right side of the motorway, with the tops of the columns to be anchored to a 1,00 m high foundation slab (invert);

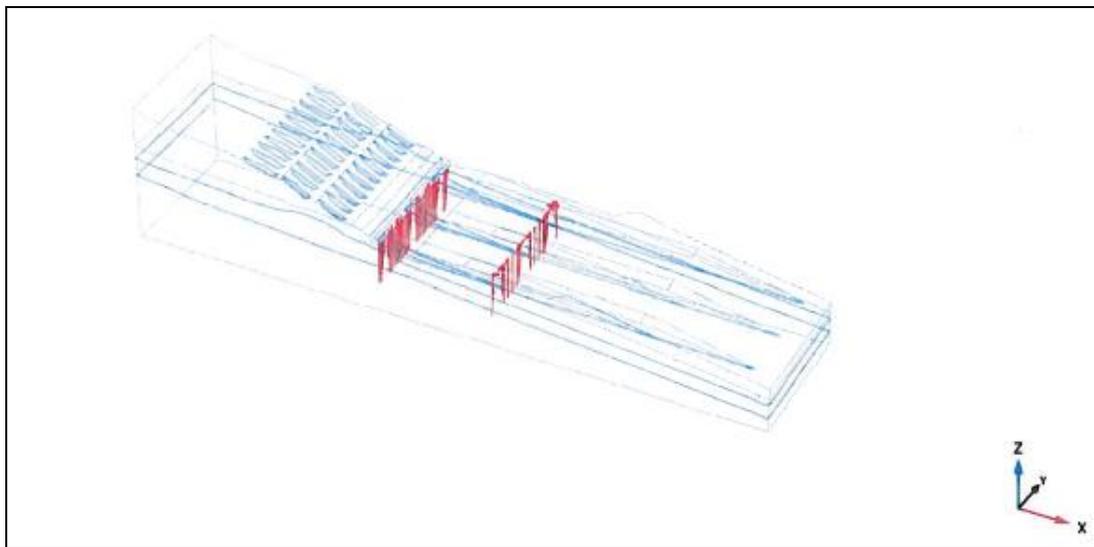
Fig. 5. Local total displacement

Figure 5 presents the results of the automatic calculation when the drains, the sliding retaining columns and the values obtained at the maximum displacement of 0.01234 m [6, 8, 9].
