SOLUTIONS TO STABILIZE THE EMBANKMENT OF A ROAD LOCATED IN THE STREAM BED OF A FLOWING MOUNTAIN WATER

Abstract: *The location of the road embankment in the proximity of a flowing mountain stream caused the road to collapse. The embankment collapse occurred as a result of erosion and scouring phenomenon. The scouring phenomena have caused the destruction of the existing support structures and the loss of the river bank stability and the erosion phenomena have caused increase of the quantity of dislocated soil from under the road structure. The article presents the root cause of the collapse and analyzes and proposes solutions to stabilize the embankments.*

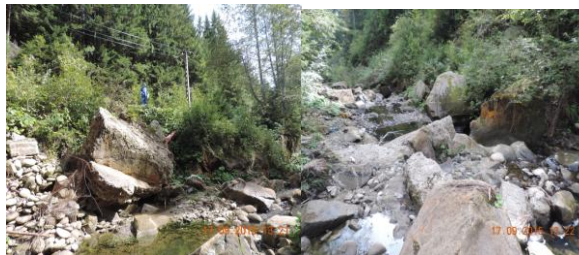
Fig. 1. Overall view of the site

During the visit on site we found the following:

- The Tazlăul Sărat riverbed was clogged in a percentage of 50-60% with large boulders and tree trunks and vegetation residue.
- We identified residues of old retaining walls made from simple concrete and gabions;

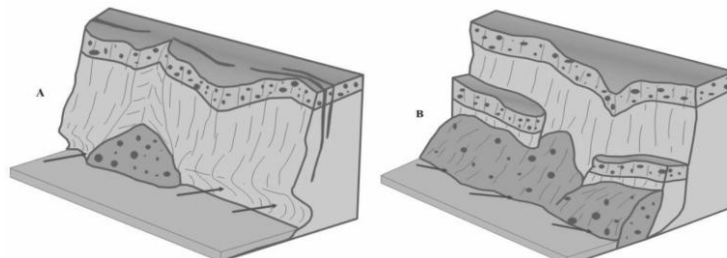
Fig. 2. The typical representation of a shore fall, after [3]
A) Before; B) After;

- the road embankment has been affected by a fall type landslide of the shore [3]. The landsliding occurred due to deterioration of the foot-slope on which the DC 130 is located caused by the erosion produced by the Tazlăul Sărat river.

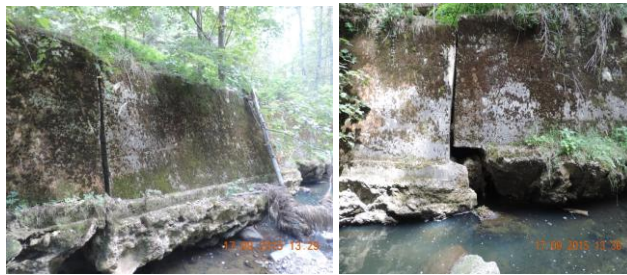
Fig. 3. Existing retaining walls proposed actions to be taken

- In the proximity of the landslide, downstream, in the Tazlăul Sărat river stream bed there is a retaining wall made by simple concrete, a wall that supports the road embankment; after a visual inspection of the wall we noticed that the first section, near the zone that we have analyzed, has suffered a type GEO failure at the horizontal translation; the rest of the seen sections are showing structural degradation as well and there is a high risk for a future type GEO rotational failure as a result of the erosion of their foundation ground, the foundations being at present on an area of about 30-40% in the console (Figure 3).

which leads to the formation of a vertical slope with heights of 3.00 - 5.00 m, to the route of the road; in this situation there is the problem of creating a system for supporting the slope in order to keep it stable during the execution of the works; to prevent the phenomenon of assaulting foundations may be carried out by unplugging the riverbed, with the arrangement of boulders recovered from the riverbed at the base of the supporting wall; as it can be seen on the site, the flow and speed of the Tazlăul Sărat River lead to the strong displacement of the terrain beneath the foundations of the existing walls (Figure 3);

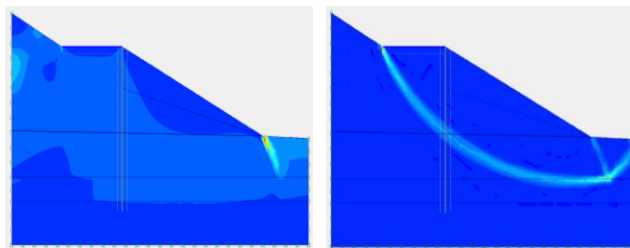
Fig. 4. Surfaces to yield calculation models I.1 (left) and I.2 (right)

- In case of arranged slope without load can be noted that failure is produced at foot of the slope by hydraulic erosion of this; in case of slope with load can be noted that failure surface have a circular-cylinder shape, the failure affectinfg the whole embankment of the road; to mention that stability factor presented are valid just in situation in which foot of the slope is not erodate by river water Tazlău Sărat. In case in which the foot of the slope is eroded, the stability factors will have subunits, fact that can be found at this moment on emplacement

- the road sloping solution without the disposal of other works to protect it, is applicable in the short term, because the slope will be eroded by the water and thus the embankment will collapse again in the analyzed point;

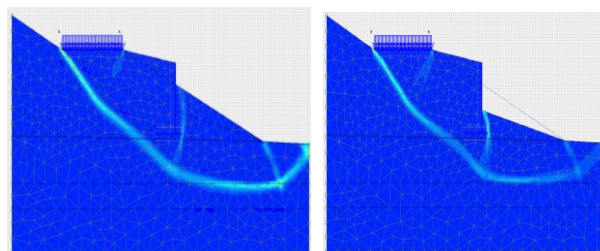
Fig. 5. Surfaces to yield calculation models II.2 (left) and II.4 (right)

- In case of supported embankment by a reinforced concrete support wall, cornier type, can be noted formation of o cylinder shape failure surface, surface who extend in depth and cover the whole supported zone; it was considered as critical situation the erosion of the foot of the slope, erosion which leads to the failure of the embankment in front of the supporting wall at a height of about 2.00 m; regardless of the analyzed situation it can be note that appear a downstream surface of the supporting wall, a surface who indicate the possibility of loss of the stability of the wall by GEO-type failure at rotation and bearing capacity;

- for the execution of support walls afferent to the minimal solution, open excavations with depths of about 2.00 m are required (depth of embroidery + depth of recess)

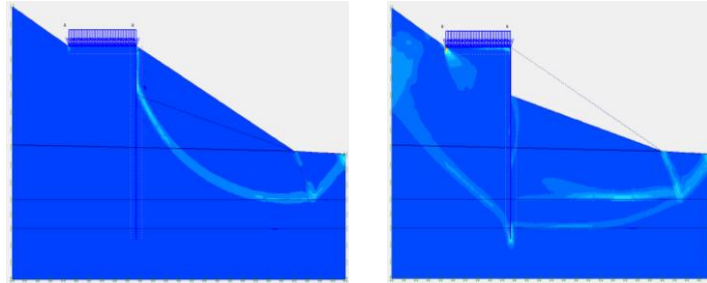
Fig. 6. *Layout Surfaces Model III.2 (left) and III.4 (right)*

- In the case of embankment supported by a drilled pilots wall with interspacings, can be noted that apperar a cylindric shape failure surface, but it is produced only downstream of the supporting wall, the road embankment presenting stability; it was considered a critical situation the erosion of the foot of the slope, erodation who can lead at failure the embankment in front of the supporting wall at a height of about 3.00 m; in this case an increase in the stability factor is observed since the failure surface is formed in depth including the entire supported area.

- execution of pilots at the roadside edge of the road provides a high degree of stability of embankment even under the assumption of a failure of the slope in front of the supporting wall at a height of about 3.00 m; to execute pilots safely it is necessary to purge the riverbed and to make a slope at the edge of the embankment by arranging the boulders in the bed, work that provides stability to the slope during the execution of the pilots as well as stability in exploitation by fulfilling the role of the anti-erosion "mattress".
