CAUSES THAT DETERMINED THE COLLAPSE OF SOME POLES FROM ELECTRICAL NETWORK IN PUBLIC TRANSPORT. CASE STUDY

Abstract: *In most cases, the elements supporting the electrical power supply networks of the public transport are made of prefabricated concrete poles with longitudinal reinforcement passive or active, by pretension. Position by poles above the road which are exposed permanently action of climatic factors and seasonal action, antifreeze protection for roads, agents used in winter for the maintenance of the roadway. The case study presented in this paper is based on an analysis and evaluation of the causes that produced failure of two poles supporting electric public transport network in Brasov, following an accidental exploitation actions.*

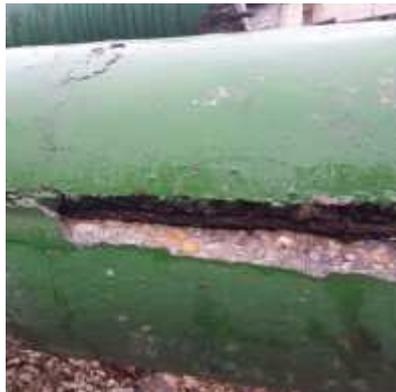
Fig. 2. Longitudinal crack after collapse

- longitudinal cracks opening approximately 1-2 mm, directed by section joining of formwork, Figure 2;

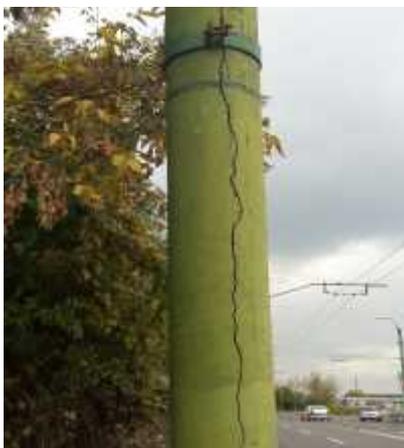
Fig. 3. Random cracks

- cracks in size and orientation uneven distributed over the length of the pole;

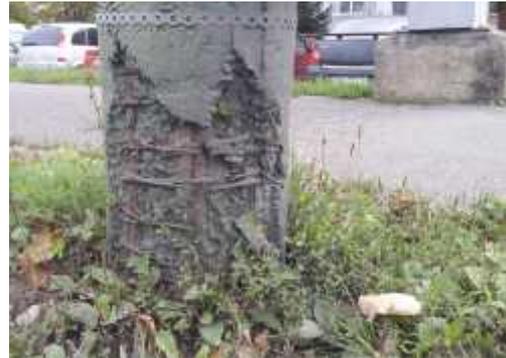
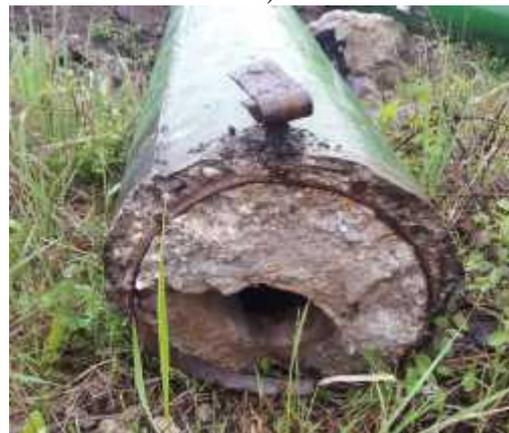
Fig. 4. Corrosion of reinforcement pole

- unveiling reinforcements in the rupture

of the pole, by highlighting the sectioning all corrosion approx. 30% of longitudinal reinforcement;

- advanced corrosion of reinforcement in longitudinal and rebar bottom of the pole;

a) in site b)after collapse
