REINFORCING SOLUTION ON EXISTING CRANE RUNWAY WITH CASTELLATED BEAMS-CASE STUDY

Abstract: *The paper presents the reinforcing solutions applied to an existing crane runway in a warehouse located in Piatra Neam city, Neam County. The crane beams are steel castellated type. The owner of the studied warehouse wanted to replace the existing 3.2 tons crane with one of 5 tons capacity. Due to regulations and norms changing over the years the existing crane runway beams need some reinforcement measures in order to fulfil the owner necessities. In the end of the paper are presented some solutions that can be adopted in order to achieve increased load bearing capacity.*

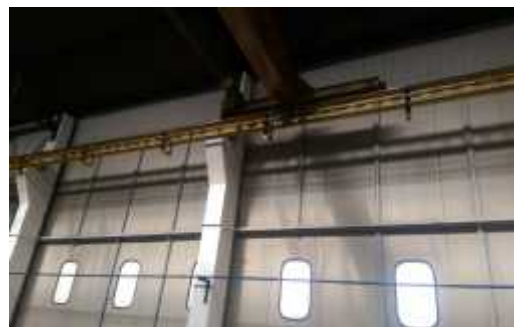
Fig. 1. *Inside of existing warehouse*

The existing building (see Figure 1 and 2), with ground floor height has the resistance

structure composed of: isolated foundations under the columns, vertical structure made with precast reinforced concrete columns with cantilevers and steel trusses, steel purlins, wind and roof bracings and steel castellated crane runway beams. The investigated crane runway has an 18.00 opening in transversal direction and twelve 6.00 m openings in longitudinal one (see Figure 3).

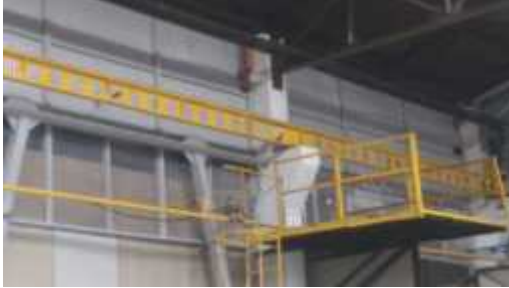
Fig. 2. Inside of existing warehouse

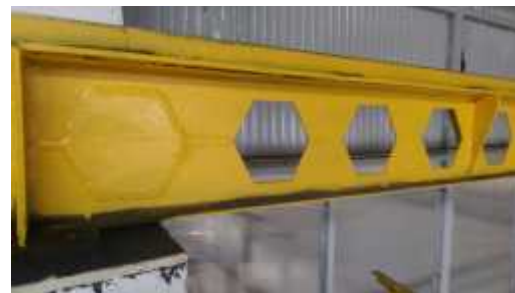
Fig. 4. Castellated beams

After current verifications on all structural elements, made by current standards, the following were found: the foundations, precast concrete columns, cantilevers and bracing system have sufficient capacity to function in both situations. The most sensitive structural elements were the castellated beams (see Figure 4) [1], [2]. The cross section for all castellated beams is presented in Figure 5. The beam section is made from welded steel plates.
