CASE STUDY REGARDING THE INFLUENCE OF THE OPERATING ENVIRONMENT ON THE DEGRADATION STATE OF AN INDUSTRIAL BUILDING

P. MIZGAN¹ I. TUNS² R. MUNTEAN³

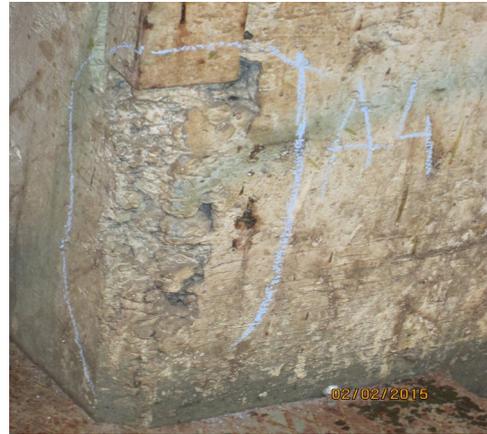
- indents of the edges caused by accidental mechanical shocks, revealing here and there the reinforcement, without determining sectional reductions – Figure 2;
- segregations here and there of the concrete, as a result of inappropriate compaction in the moment of pre-casting on site – Figure 2;
- the cover concrete layer is insufficient

Fig. 2. *Highlight the indents and concrete segregation – A4 pillar in A axis*

As it was highlighted above, the causes of degradations are due as a result of an accidental mechanical shock, execution defects, plastic slump of fresh concrete, concrete carbonation through CO₂ action, chemical corrosion of concrete and

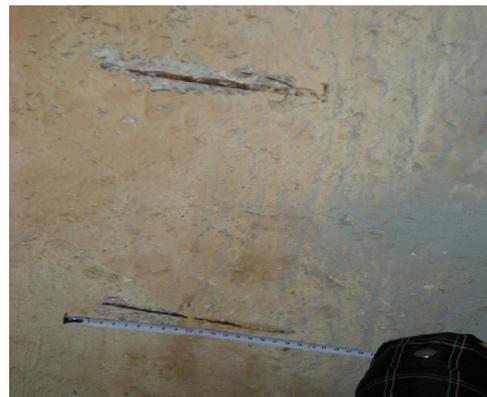
in some areas ($0.5 \div 1 \text{ cm}$) – Figure 3;

Fig. 3. *Highlight the insufficient cover concrete layer – A7 pillar in A axis*

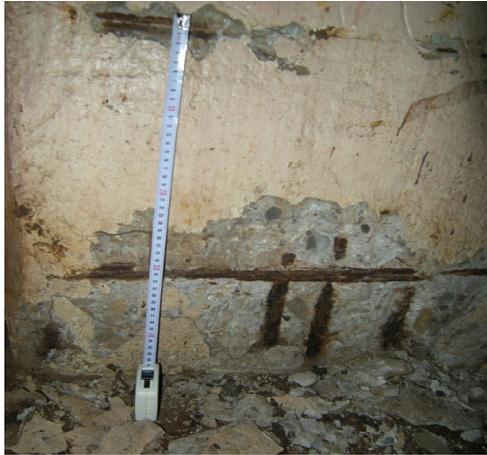
- degradation through concrete carbonation, the detaching of the superficial concrete layer and local sectional reduction, the uncovering of the casing favoring its corrosion process; these degradations are produced at the inferior section of the pillars, predominant for pillars within A axis – Figure 4 and 5;
- visible cracks of the concrete in the direction of the clamps as a result of plastic slump after casting and the insufficient thickness of the covering concrete layer;

Fig. 4. *Highlight the degradation through concrete carbonation; reinforcement corrosion – A2 pillar in A axis*

The emphasized degradation state of the A axis pillars, respectively in their inferior area, has been produced by the following mechanism:

- in time carbonation of concrete and the destruction of the protective film of the reinforcement;
- oxygen inflow through formed cracks and eventually through the pores caused by the flawed casting of the concrete;
- water inflow through cracks, casting pores and capillary pores;
- reinforcement corrosion and the concrete superficial layer expulsion.

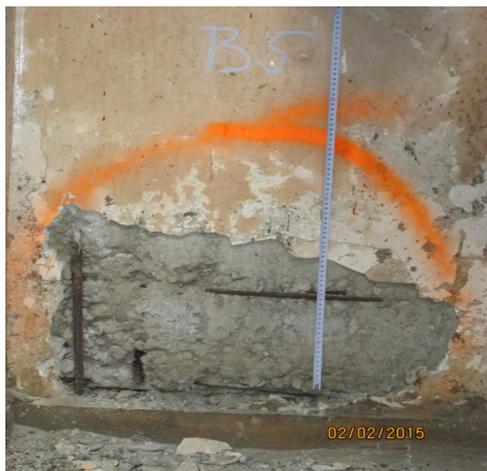
Fig. 5. *Highlight the degradation through concrete carbonation – B5 pillar in B axis*
