# WATERPROOF EXPERTISE OF AN OBJECTIVE WITH BRICK WALLS AFFECTED BY CAPILLARY MOISTURE

**Abstract:** *Removing moisture from the capillary walls affected by rising dampness is a priority for the historical sites in question. Appropriate measures and method of intervention varies from one situation to another, especially when the financial factor is decisive. For Romanian Orthodox Diocese in Hungary, St. Nicholas Cathedral from Gyula, some of the methods with high efficiency rate over time are suggested. It is about Drykit, Dryzone respectively, and Comer. They come as a result of the on-site technical expertise. Specific intervention works from the outside and inside will be complemented with other related, aimed at removing the floor effect, foundations ventilation, remediation of fallen plaster and damaged paintings.*

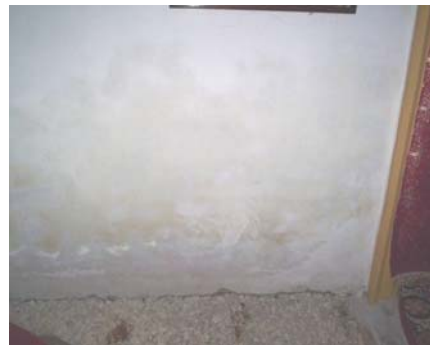
- Blooms can be observed on some parts from plaster face. Migration of salts from walls also led to the appearance of efflorescence (Figure 1 and Figure 2).
- Stone floor has a high humidity level, ranging to around 22-28%.

Fig. 1. *Blooms and coloured spots on the plaster*

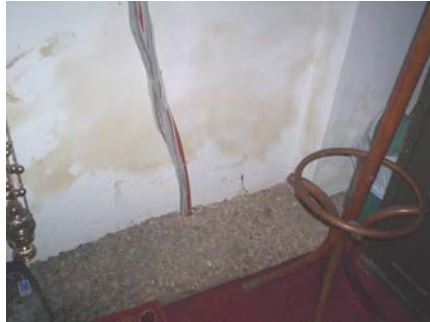
Fig. 2. *Coloured spots on the coating, caused by migration of salt from walls*

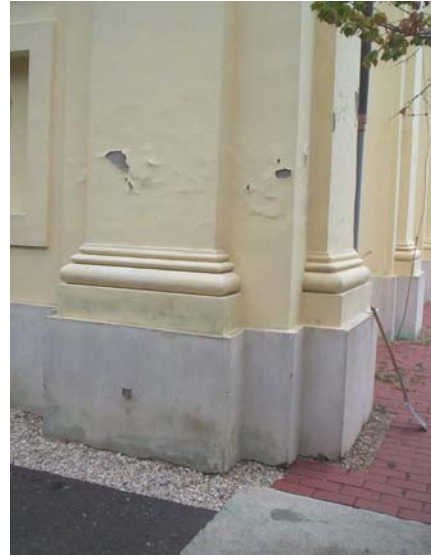
- From the analysis of relative humidity in terms of vertical variation, at the plaster level (the latest repairing was made in previous years with Baumit W mortar) can be said that the humidity rises in capillary walls (of thickness between 1.6 m and 2.6 m) until above the rate at which aerated plaster ends, at about 2.5 m (Figure 4).

It can be said therefore that the effect of mortar from the plaster is reduced because of high moisture contained in the walls.

Fig. 4. *Variation of capillary moisture in wall height*

Without adopting a radical action to break capillarity, the plaster effect will decrease even more over time due to clogging pores with salt, emphasizing the phenomenon of dampness.

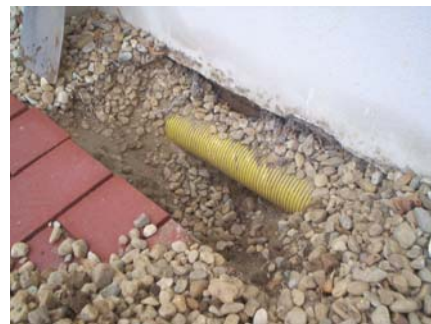
- A ditch is made on the outside perimeter of the church with about 30 cm deep and 30 cm wide, and changes a drain covered with granular crushed stone grade (25-30) mm.

Unfortunately, poor execution and lack of maintenance have led, in time, led to loss its initial role. This can be observed on Figure 5.

Fig. 5. *Ditch structure*
