# ANALYSIS ON THE DEGRADATION STATE OF THE SITE OF CERTAIN RESIDENTIAL BUILDINGS

**Abstract:** The facts presented in the paper were generated by the implementation of a section of sewerage near and below the foundation level of a retaining wall with the role of maintaining the stability of several residential buildings.

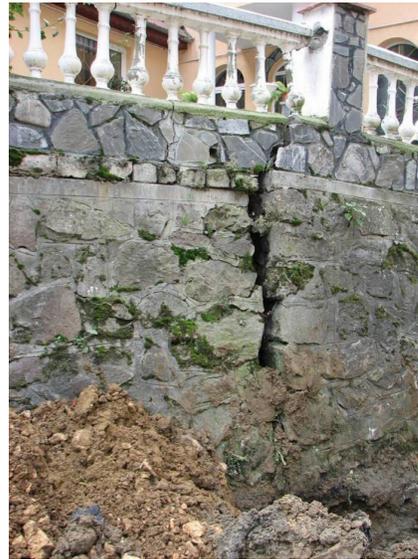
- the large opening of the settlement joint at the same time with several horizontal displacements of the exterior sides of the two adjacent sections of wall, Figure 3;

Fig. 3. *The large opening of the settlement joint*

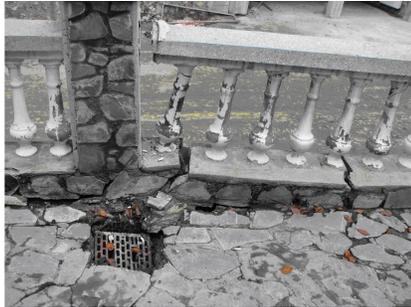
• degradation of the upper wall and of the bulwark of protection, by spotting several large opening cracks, uniformly distributed, with horizontal and vertical displacements of the their bordered parts, Figure 4;

Fig. 4. *Degradation of upper wall area and of the protection bulwark*

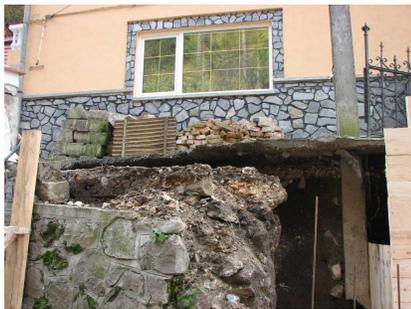
• breaking off of several sections of wall masonry at the same time with the crash of the soil behind it, Figure 5;

Fig. 5. *Break off section of the masonry wall and the crash of the ground behind*

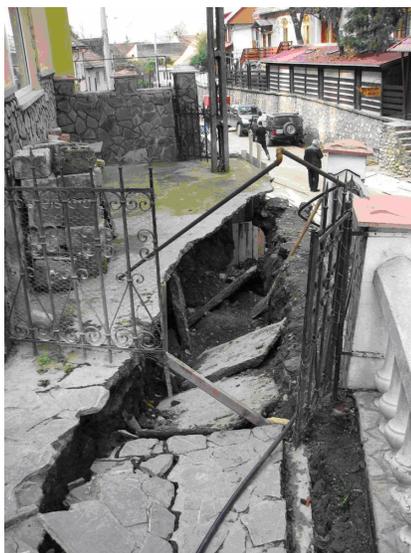
• linear and angular displacements of the retaining wall and the formation of massive deep caverns in the ground behind it, Figure 6;

Fig. 6. *Formation of massive caverns behind the retaining wall*

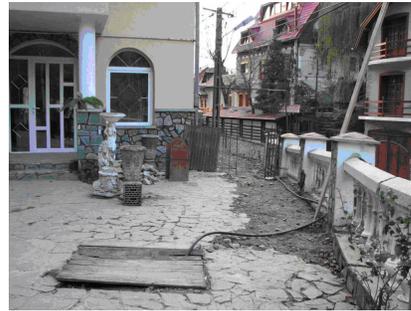
- the infiltrations of water into the ground due to the lack of tightness of the pluvial sewage for the surface waters located in the yard of building no. 14, Figure 7;

Fig. 7. *Water infiltrations from the pluvial sewage*

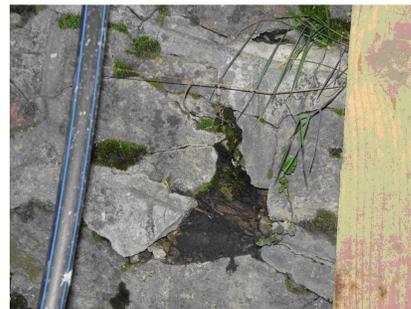
- the continuing action of the environmental factors has fully contributed to enhancing the state of degradation by the presence of cracks in the stone block, exfoliation of joint plaster, breaking off of stone blocks from the wall, vegetation growth, Figure 8.

Fig. 8. *Wall section with wide cracks, break off of stone masonry and vegetation growth*

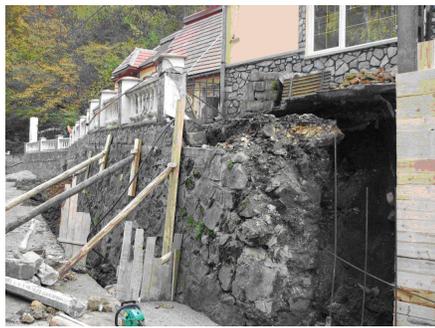
Fig. 16. *Temporary blocking the basis and supporting the wall*

To temporary restore the situation caused after the execution of sewerage works, it was proposed and also applied the blocking of displacement of wall basis by filling the excavation with a concrete of class C5/7.5 and by temporally supporting the wall, Figure 16.
