DEGRADATION FORMS OF FOREST GRAVEL ROAD ROADWAYS UNDER HEAVY VEHICLES USED IN TIMBER TRANSPORT

Abstract: *The conducted research followed the establishment of degradation forms of forest roadways and their extending on the forest road Pravăț, as secondary gravel road. The obtained results, both, on recorded degradations types and their dimensions demonstrate that degradation, even in conditions of reduced traffic, can affect approximately 0.2% from the roadway surface. The obtained data is useful for annual planning and time distribution for repairing-rehabilitation operations.*

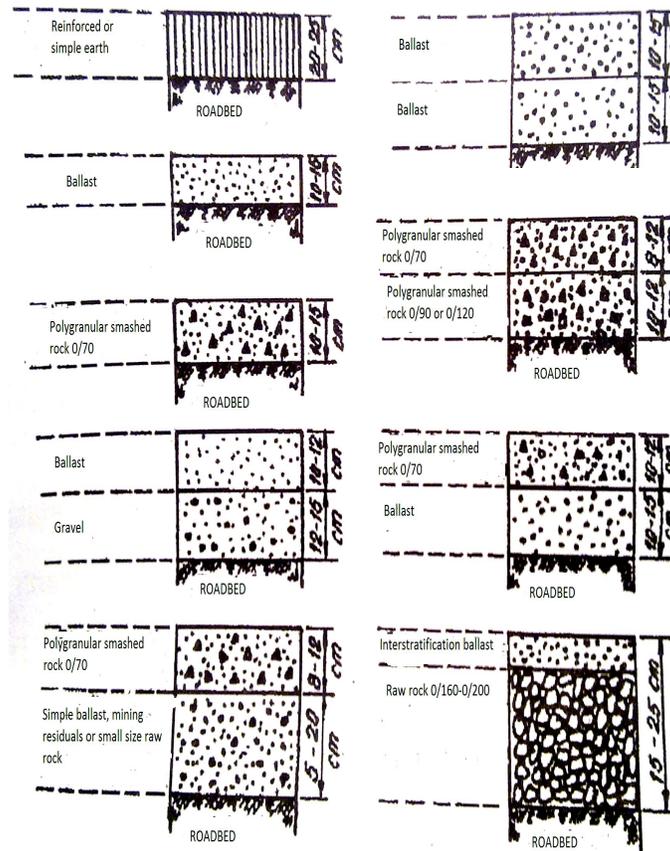
Fig. 1. Road systems for secondary forest roads

The reinforcement modality depends, generally, on forest traffic intensity, which presently is situated under 5.000 tones/year corresponding in this way to secondary forest roads [1]. The road systems recommended by the currently applied normative, which were elaborated in conditions of realization of a concordance between the traffic intensity and bearing capacity of the roadway for secondary forest roads, are presented in Figure 1.

As it results from Figure 1, the mentioned roads present 1-2 layers, being made of rocky

When the road system contains only one layer (ballast or smashed poly-granular rock) it presents a thickness of 10...15 cm, having both, bearing and crust functions; in case of two layer systems (foundation with bearing function and cover - crust function), the first one is realized of local materials (ballast or gravel) and has a thickness of 15...20 cm; in some cases a raw rock foundation can be used (sort 0/150...0/200) having a thickness of 15...20 cm. The cover layer is executed similarly to one layer systems, respectively from ballast or poly-granular smashed rock, having a thickness of 10...12 cm in one layer construction and 25...30 cm in two-layer construction.

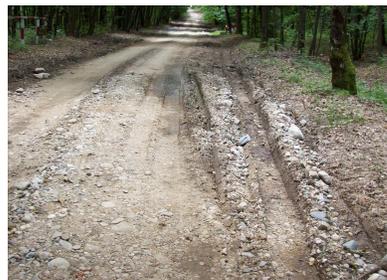
Fig. 2. *Pravăț forest road*

Pravăț forest road (Figure 2), having a length of 2.5 km, is a secondary road and assures the annual transport of 11,000 tones of wood.

The geometrical and constructive characteristics of the road, according to its design project and field measurements are:

- design speed: 15 km/hour;
- average platform width: 5.2 m;
- average roadway width: 3.5...4.1 m;
- shoulder width: 0.375 m;
- minimum radius: 20 m;
- maximum longitudinal rise:
 - on loaded transport: 9%;
 - on empty transport: 12%;
- visibility distance: 40 m;
- the confidence degree on torrential events: 3%;
- recommended road system: simple gravel with two ballast layers.

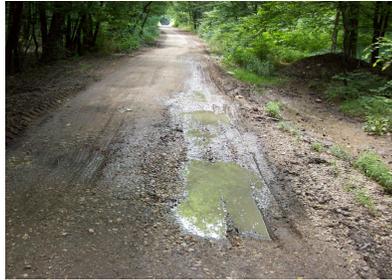
Fig. 3. Holes and wavings on Pravăţ forest road

- the depths on which the roadway was affected vary between 4 and 43 cm; the deepest degradations were encountered in case of frost-melting dips, and the most reduced in case of wavings; encountered degradations confirm the fact that, during road exploitation, the most intense stresses are produced under the corroborated action of traffic and climatic factors;

- determinations regarding the depths of degradations showed that sometimes only the cover layer is affected, a fact which is justified by tangential solicitation actions occurring especially on the surface contact level; on the other hand, just like in case of holes, heavy use affects the entire road system, sometimes even the road bed (frost-melting dips);

- supplementary observations realized on field, showed that on the Pravăț forest road, heavy use has provoked greater degradations (Figure 3) than those encountered on other roads from the studied area, endowed with

2 traffic lanes in the same traffic conditions; the phenomenon is augmented by the fact that in the case of 2 lane roads the traffic is realized on both lanes, and in the case of one lane Pravăț road, the existing lane serves traffic in both directions;

- The obtained results, as the formulated conclusions impose the permanent deployment of a repairing-maintaining action, as well as a periodical rehabilitation of the road.
