ANALYSIS OF REHABILITATION SOLUTIONS FOR MASONRY BUILDINGS

A. PODAVKA¹ S. DAN¹ A. POP¹ M. COCIUBAN¹

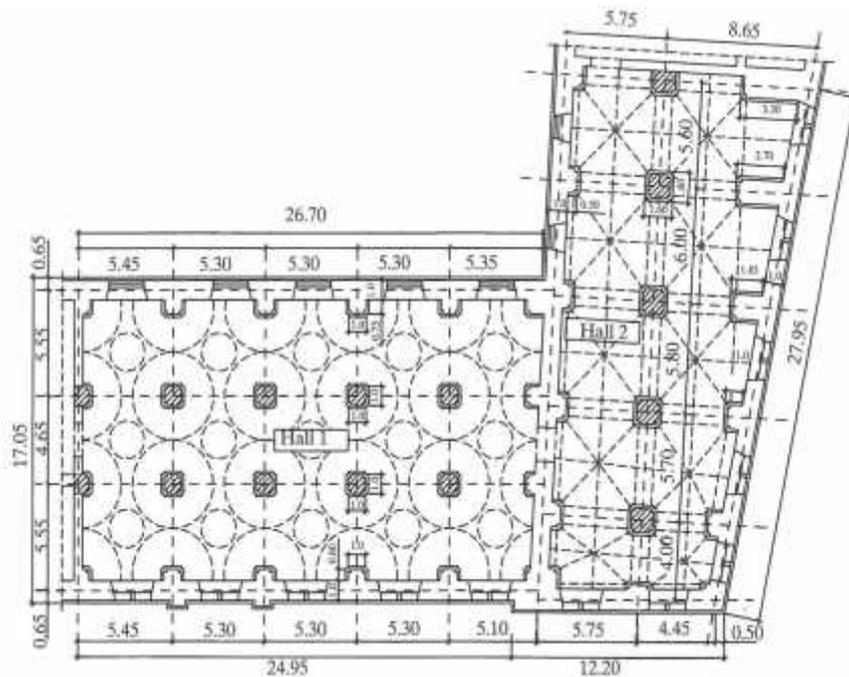
Fig. 5. *Horizontal section at second story through Hall 1 and Hall 2*

The main damages of the actual structure of the building are located inside the Halls 1 & 2 and are characterised by cracks in the masonry walls: maximum width of 5 cm at upper part (Hall 1) as well as in the brick arches, especially in the vault head (5-8 mm). Such cracks were caused by both, earthquake actions and soil settlement due to bad soil, non-uniform foundations and soil water level.

The rehabilitation of the foundations soil represents an important step for improve the structural safety at different actions. The soil characteristics are increased by infilling a bentonite-cement slurry. The infilling material has to act as: soil stabilisation under and around foundations; to infill the holes and joints of the existing foundations. The injection with the bentonite-cement slurry is used between 1.5 and 8.5 m levels.

The foundation ground was improved by injections with bentonite solution, the foundations were strengthened by interior and exterior reinforced concrete plaster and a reinforced concrete slab on the ground floor was provided.

- reinforcement of the cracks in vaults and arches with epoxy-resin-based injections and Carbon Fiber Reinforced Polymers(CFRP) plaster;
