THE STRUCTURAL REHABILITATION OF THE BASEMENT OF A BUILDING WITH BRICK MASONRY STRUCTURE

Abstract: *The paper presents the structural rehabilitation solution that was applied to the basement of a masonry building, design at the beginning of 20th century. In the first phase of structural evaluation, was determined the causes of masonry decay based on visual and on site investigations. Secondly, was evaluated the building safety and proposed the strengthening solutions. The strengthening of the masonry columns was made with reinforced concrete jacketing and in the area where the vault collapsed were used a new structural system made of steel.*

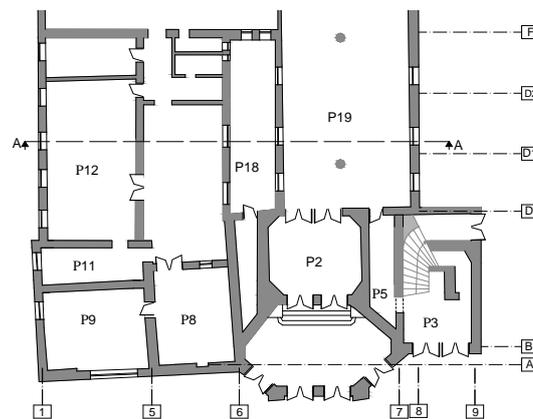
Fig. 2. *Ground floor plan*

As the ground floor is erected over the basement, the attic floor is supported on two columns in axes F and D1 (Fig. 2), starting from the foundations and passing through, up to the attic floor.
